ACLOUD Flight #04 – Polar 5 – 170523

The main goal of the flight was a study of the cloud development during a coldair outbreak over the Northern Fram Strait. Secondary goal: Nose boom calibration.

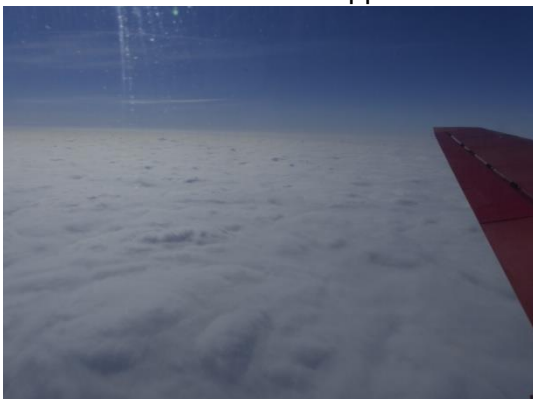
Although convection rolls could be seen in the satellite image, during the whole flight section from C1 to C2 clouds appeared to be homogenous (complete cloud cover; stratus and stratocumulus). Only over the sea ice part close to half the way between C3 and C2 convection rolls were visible.

Cloud situation between C1 and C3 (left).

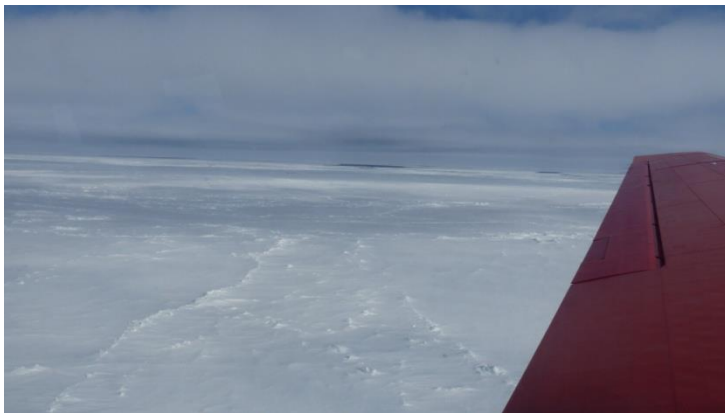
At C2.

At C2 there was 95% sea ice cover with open small leads (no nilas visible) and polynyas (estimated width 100 – 200 m).

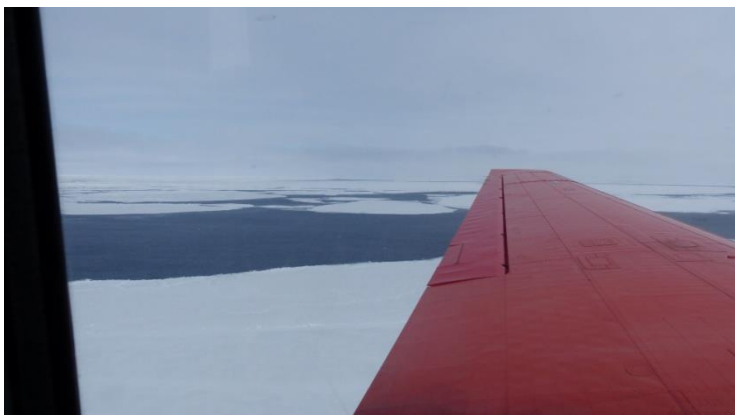
Between C2 and C3

Further south, the number and width of leads increased (see below).

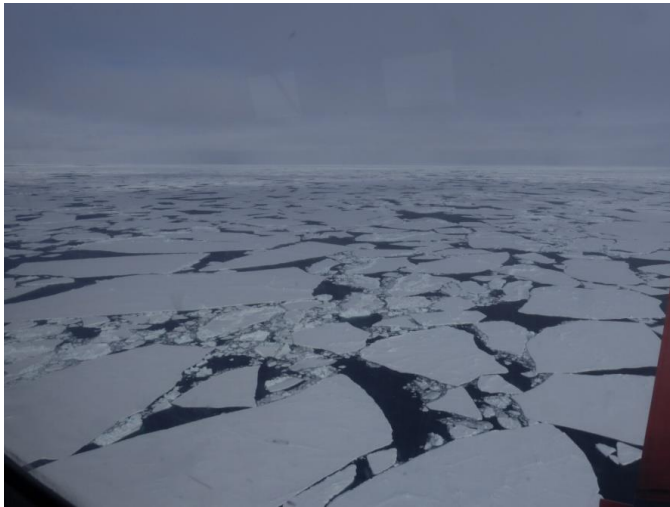
Half the way between C4 and C5

Between C4 and C5 sea ice opened more and more and the typical ice floe structure of a marginal sea ice zone developed.

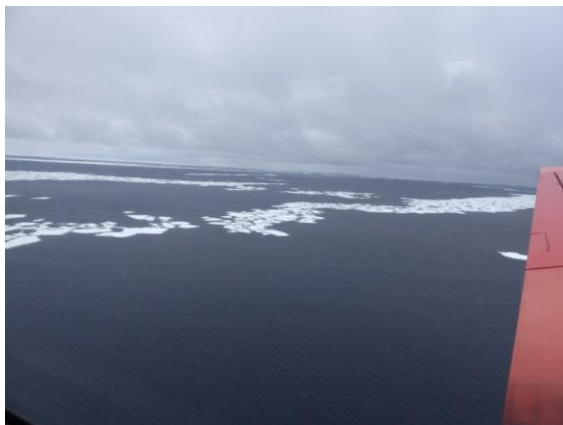
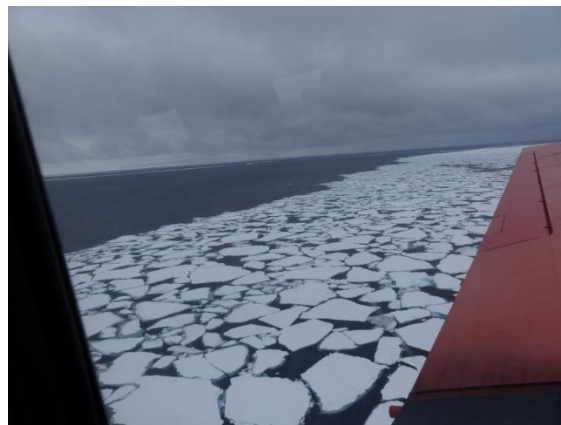
The ice edge was reached at about 79 N 5 E (see foto below, left).

But close to C5 there were still some drifting ice fields (right foto, above). The foto has been taken shortly before the low-level section had to be terminated .

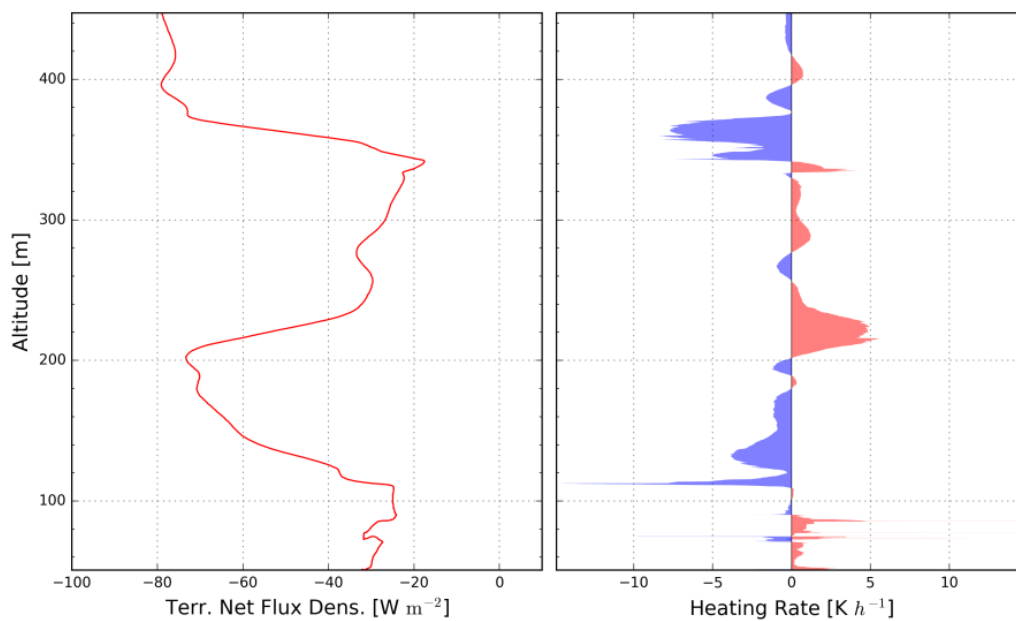
Fig. Q1:
Radiation
data

Figure Q1 shows the terrestrial net flux density profile measured during the first descend at 80.6545 N, 3.532 E down to 200 ft (Time: 10:52 UTC / SOD 39125 - 39290, Lon 3.532 E, Lat 80.6545). A double layer structure can be seen with derived cloud top cooling for the upper layer of up to -8 K hr^{-1} and cloud base heating of 5 K hr^{-1} (Johannes Stapf).
