# **AFLUX Flight 07 – Polar 5 – 30.03.2019**

**Mission PI: Dmitry Chechin**

Turbulent and radiative fluxes and cloud microphysics in the low-level clouds in different conditions: 1) in the absence of mid-level clouds and 2) in their presence. Thus, a staircase pattern is planned in two locations: with mid-level clouds in the west and without the mid-level clouds in the east.

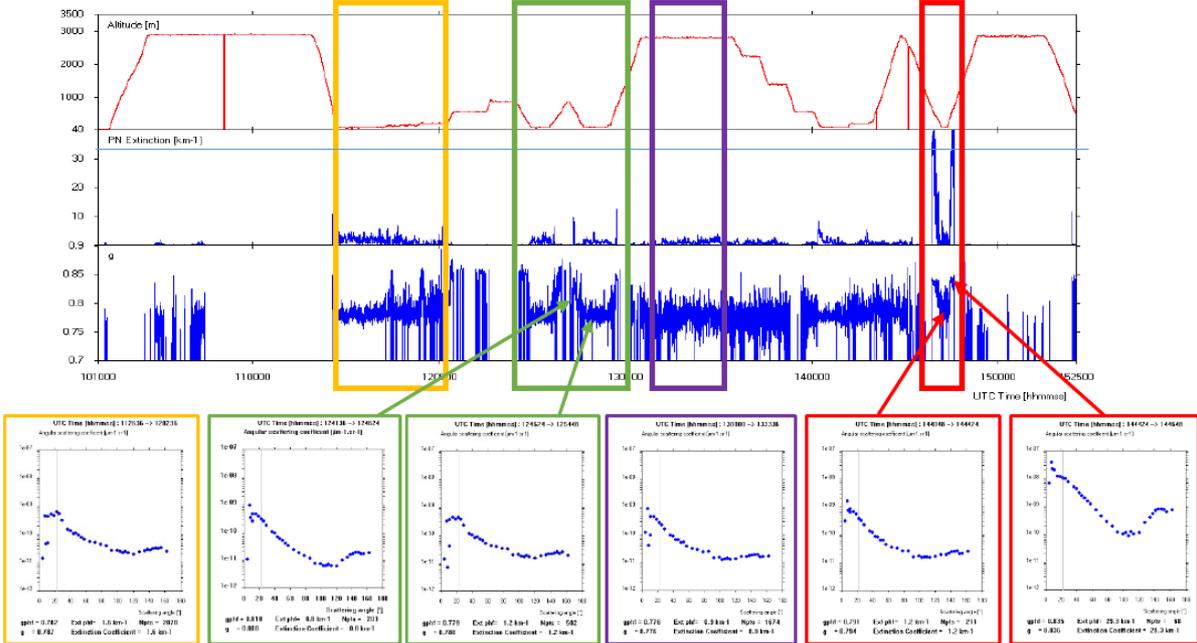
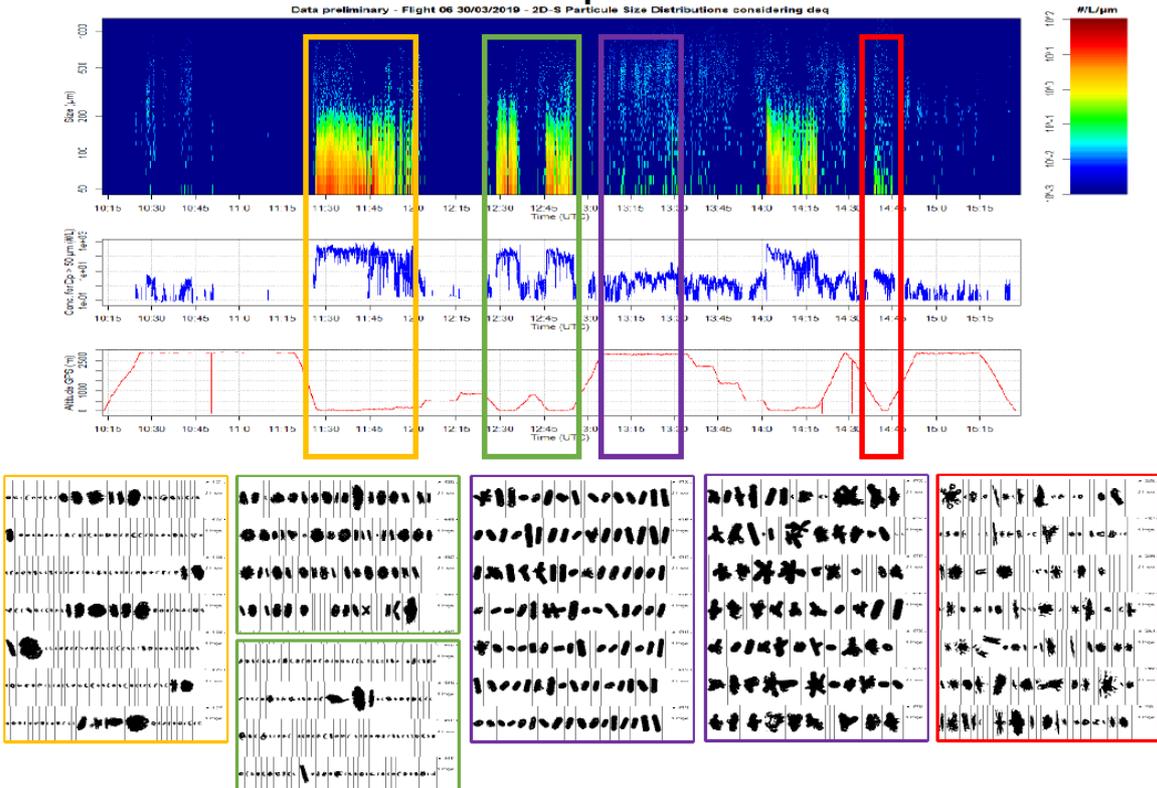
Quicklook 3. The quicklooks from the 2DS and PN cloud probes.

## Polar Nephelometer

## 2DS probe
