MOSAiC-ACA Flight #10 – Polar 5 – 2020/09/11

Objectives:

Characterize the lee effect of Svalbard on atmosphere and cloud conditions in south-easterly wind conditions by dropsonds and remote sensing. Profile multi-layer clouds over sea ice and over open ocean by in situ observations in different altitudes.

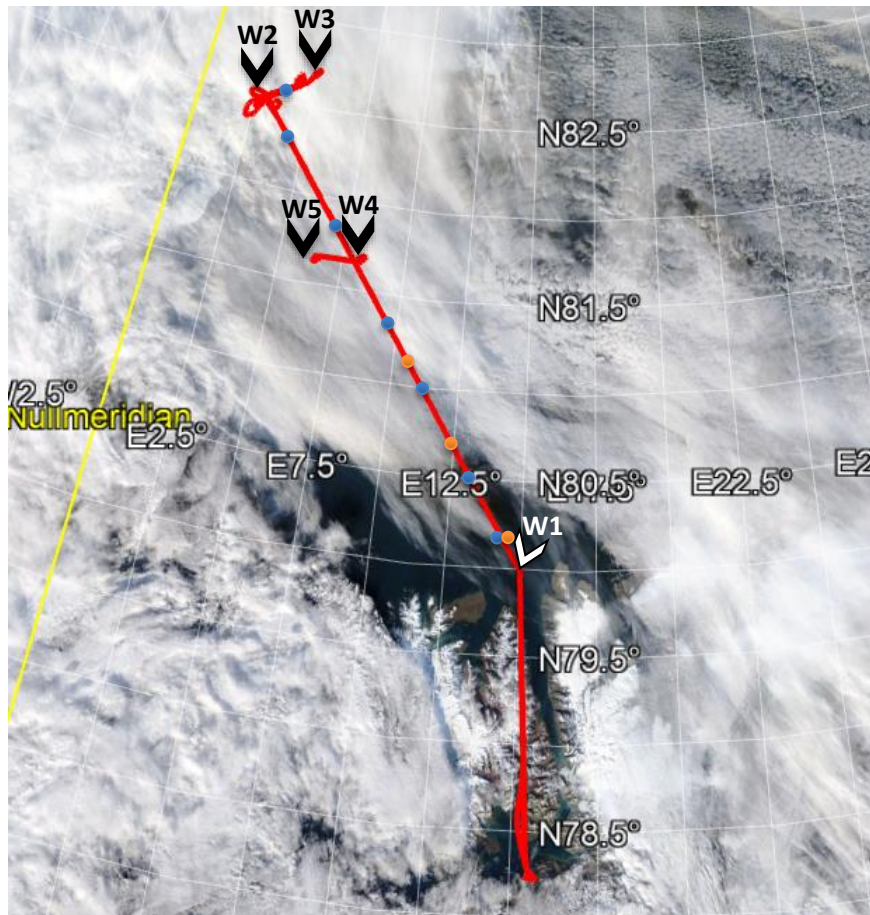
Fig. S5.1: MODIS (Terra) satellite composite and Flight Track of Polar 5. Blue dots indicate the location of dropsond releases outbound, green dots inbound.

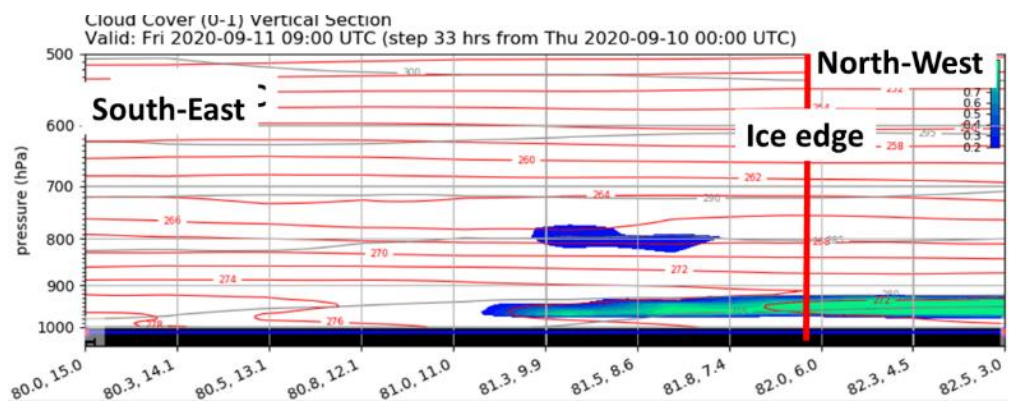
ECMWF cloud cover cross section along the flight track shown above.

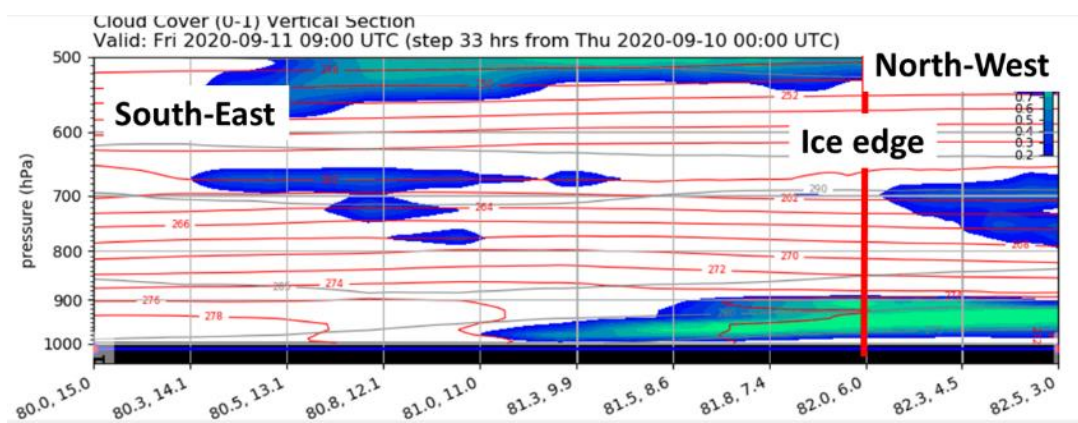
ICON cloud cover cross section along the flight track shown above.

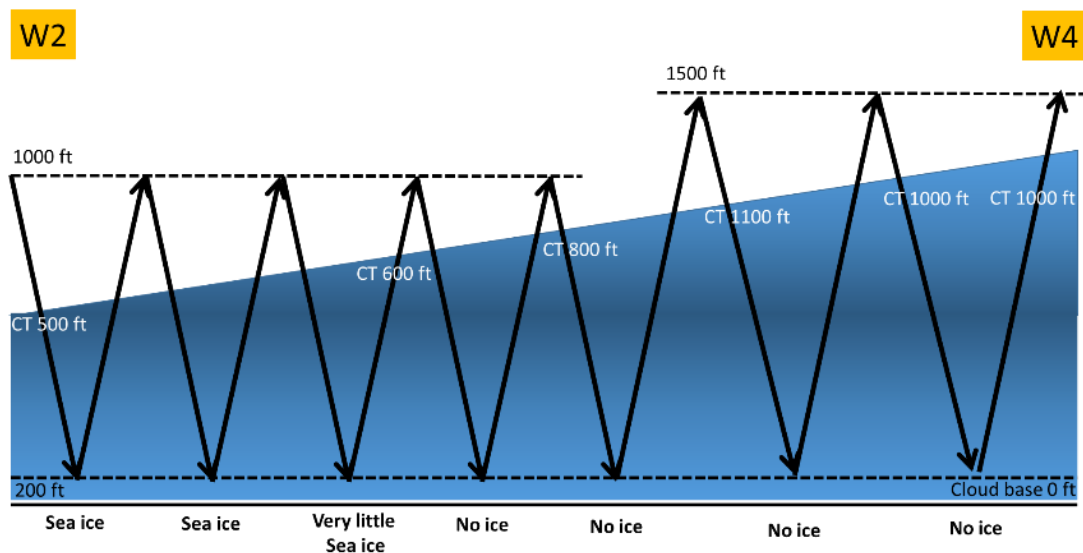
Saw tooth pattern between W2 and W4.

Returning to location of the second stack, we descended to 200 ft and started a saw tooth pattern to repeatedly sample the low cloud as often as possible to obtain good statistics but also for following the changes of cloud properties. Other than expected, the cloud top altitude increased towards South. These clouds always reached the ground (first sea ice, then open ocean). During this leg, also mid-level and cirrus was present. The altitudes of the saw tooth pattern is illustrated below.

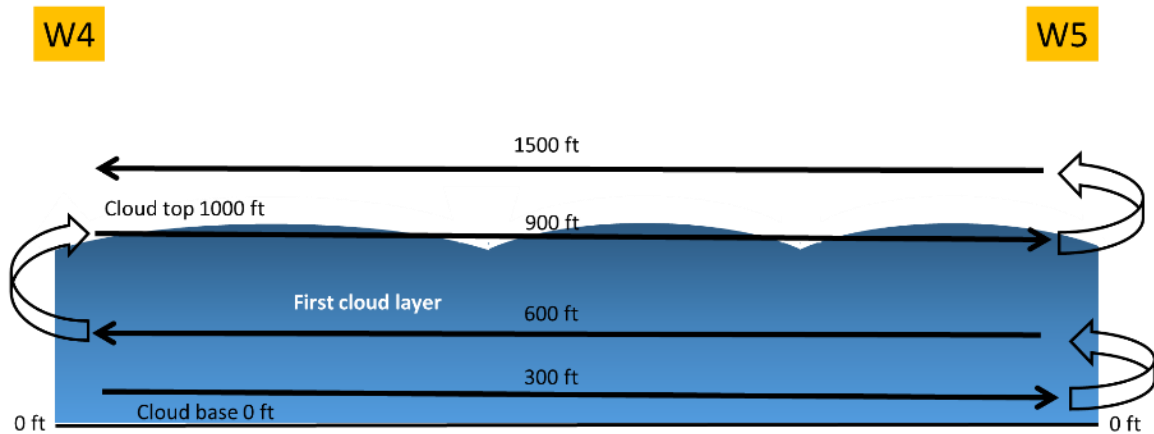
Altitudes of the second stack between W4 and W5.

At the location of the second stack only one low cloud layer was present, except of high cirrus. A mid-level cloud was not visually obvious but was discovered later, when climbing to 10 000 ft. This stack was compiled of four different legs. The low cloud layer was significant thicker than in the north but also reached the ocean surface. The stack is illustrated below.

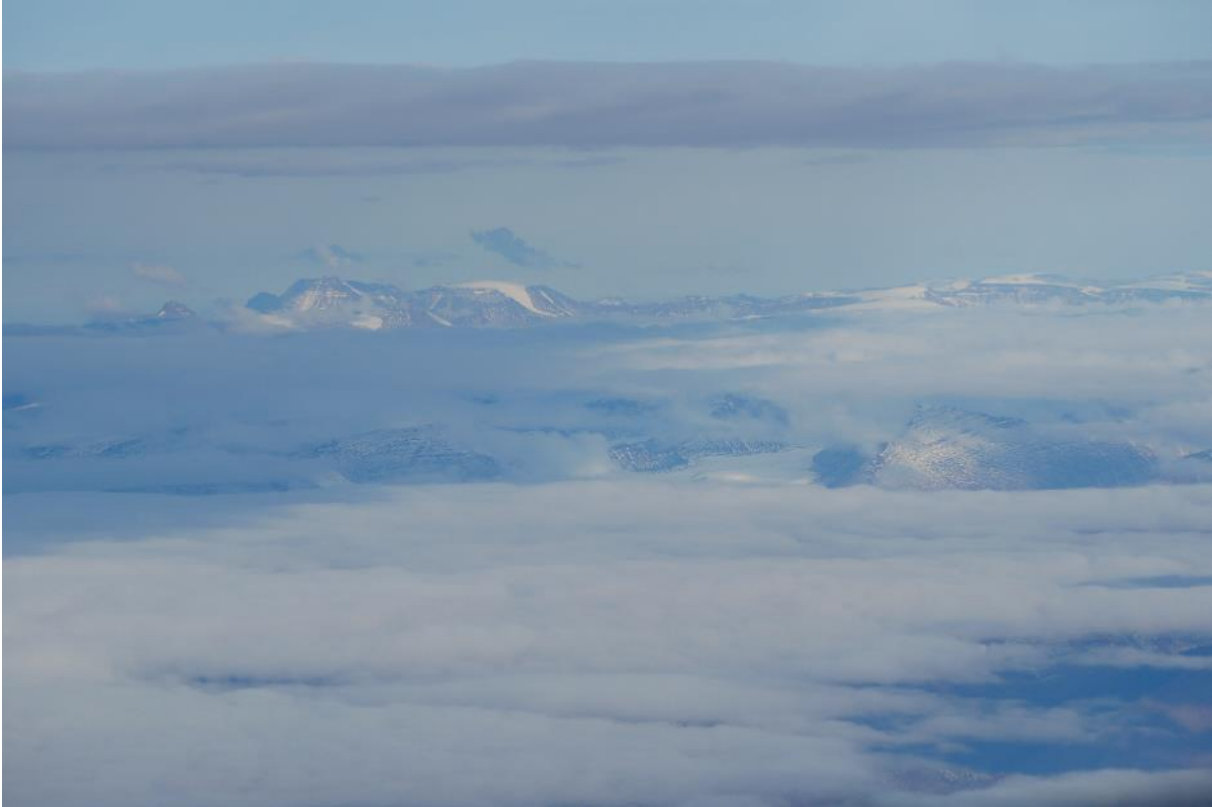
08:23 UTC – inhomogeneous clouds over Svalbard

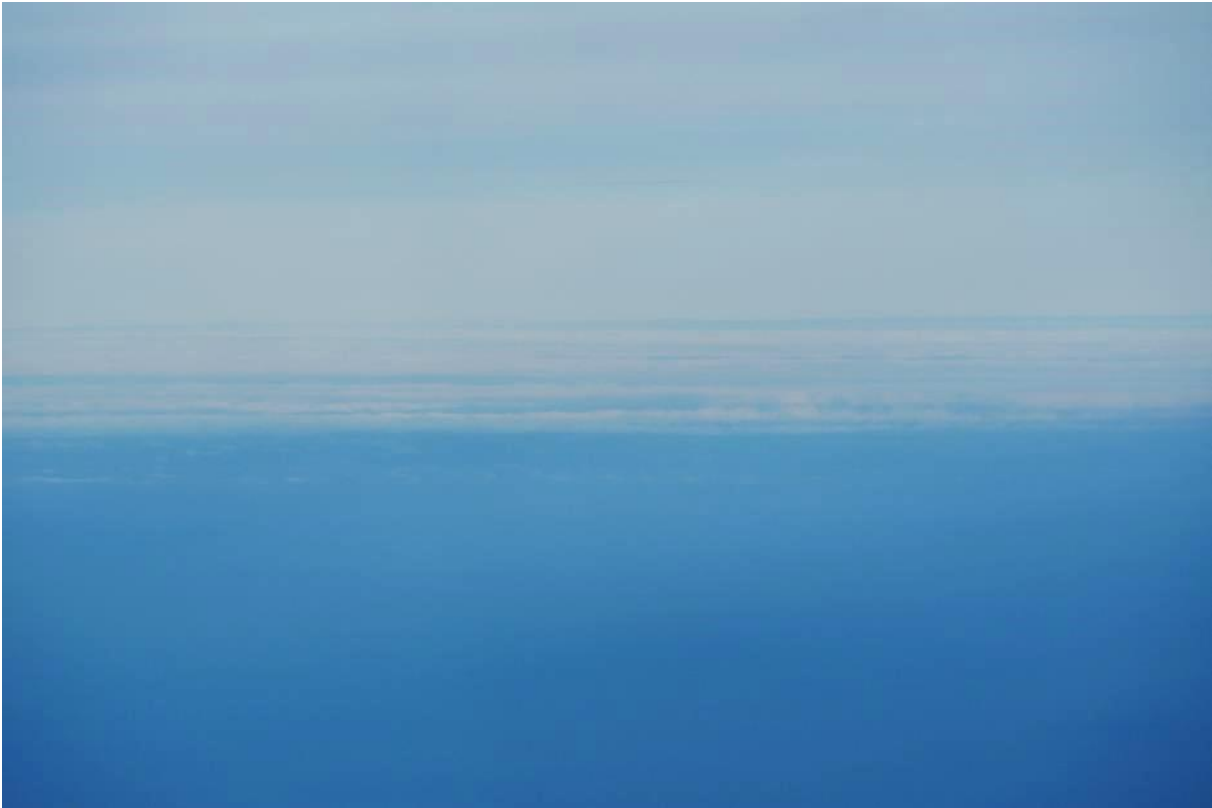
08:45 UTC cloud free area in the lee of Svalbard

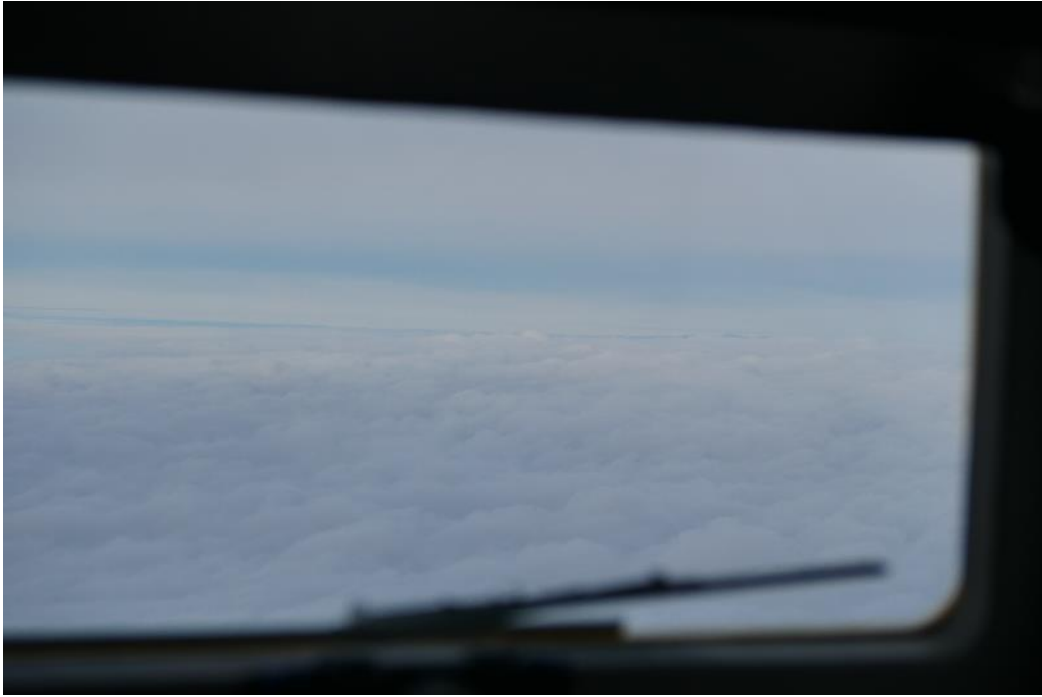
09:33 UTC The low clouds became more structured with higher clouds tops.

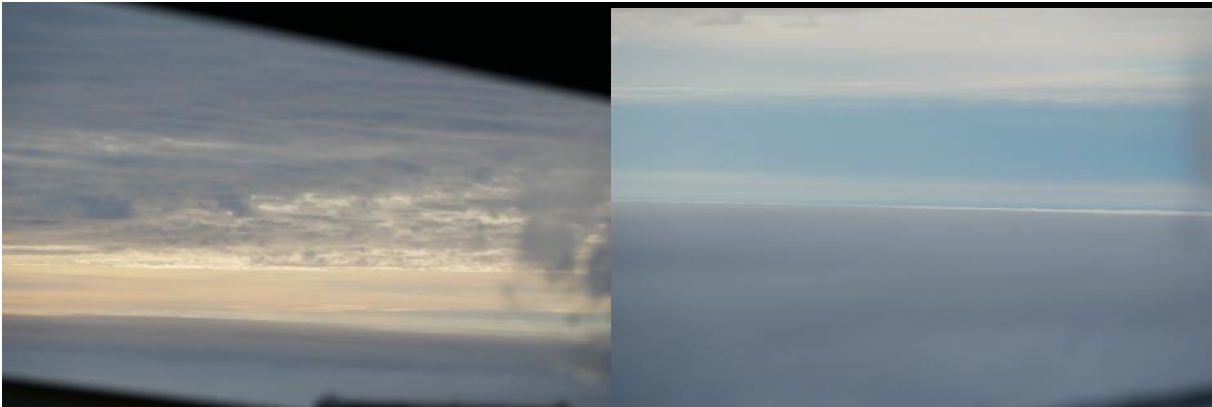
10:21 + 10:23: between the two cloud layers

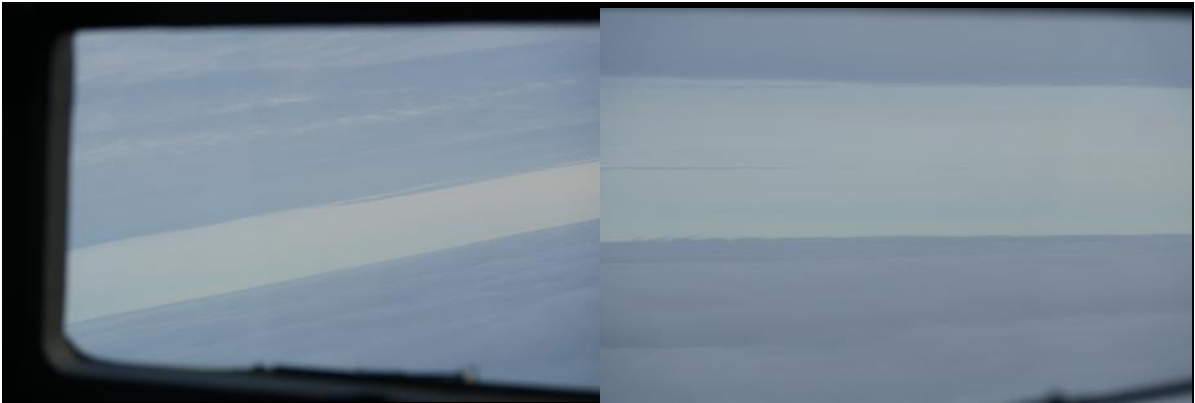
12:21 + 12:26: Between the two cloud layers.

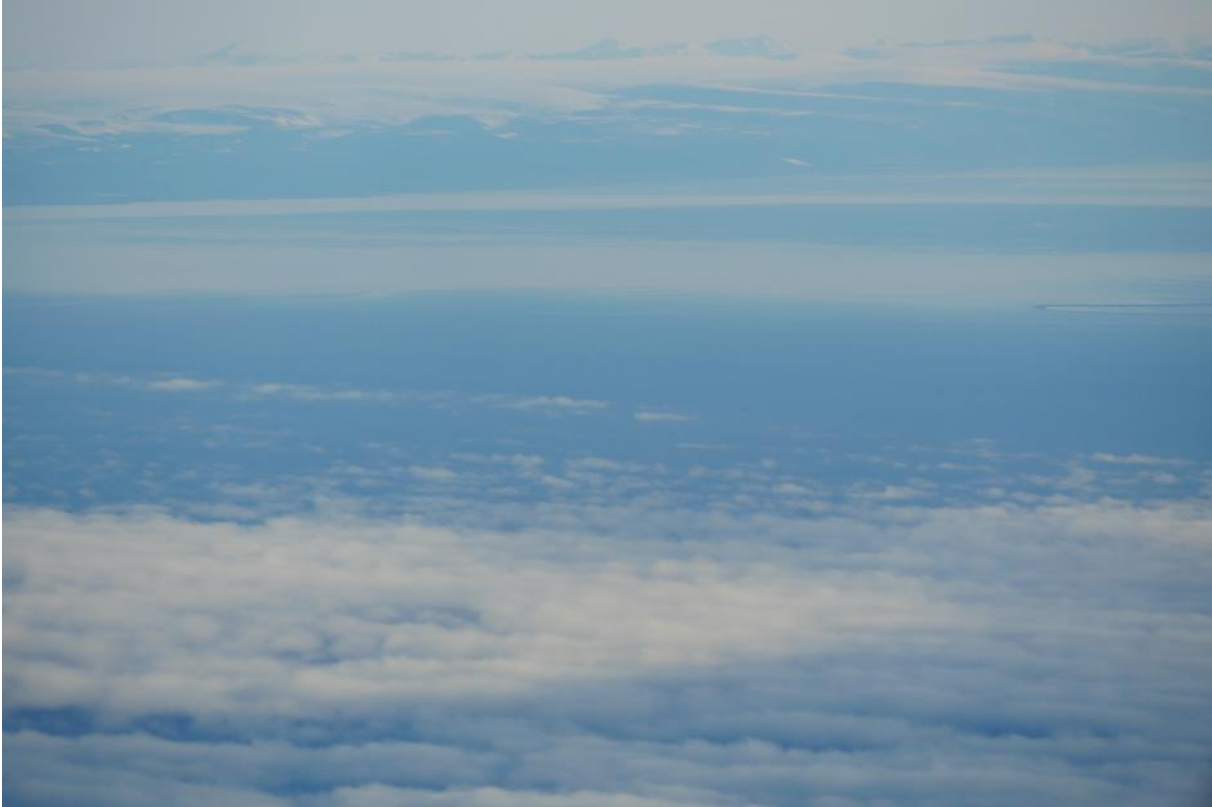
12:56: End of the low level cloud, right before the lee cloud hole.

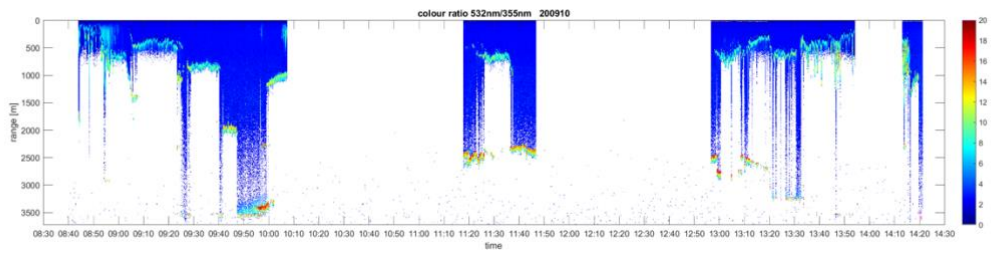
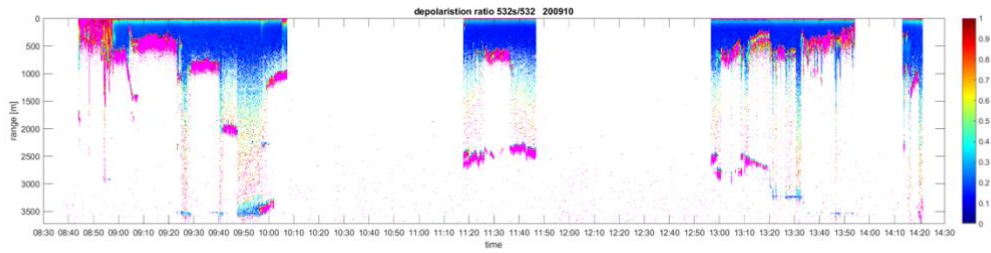
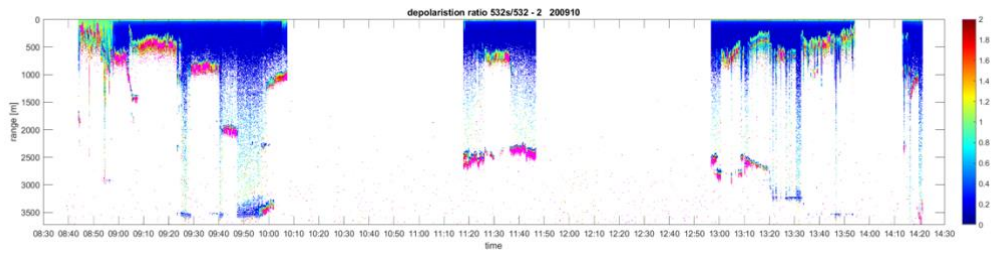
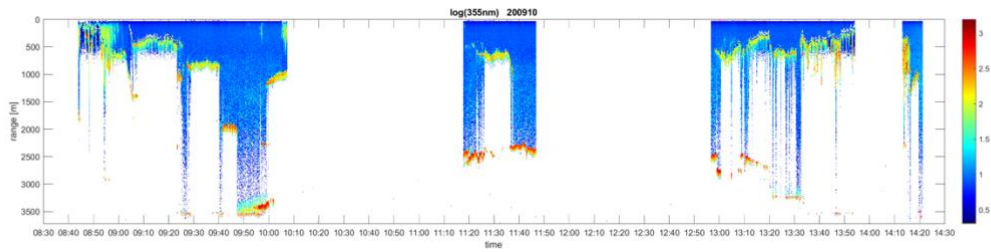
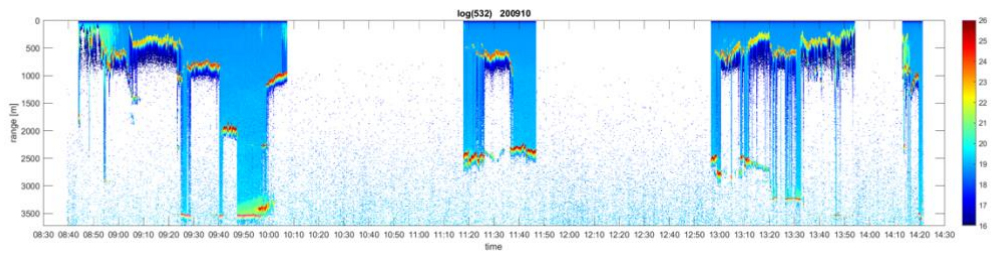
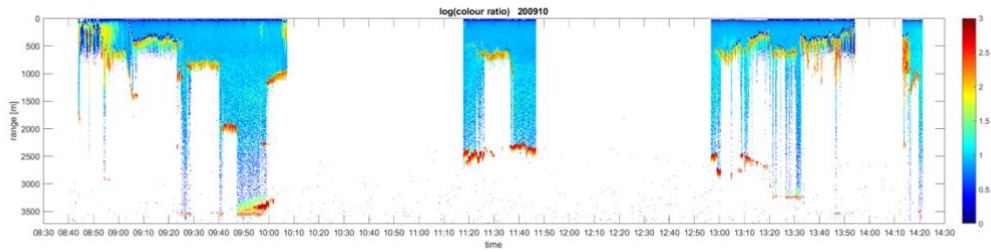
Quicklook Flight 09, 10.09.2020

AMALI 20200910:

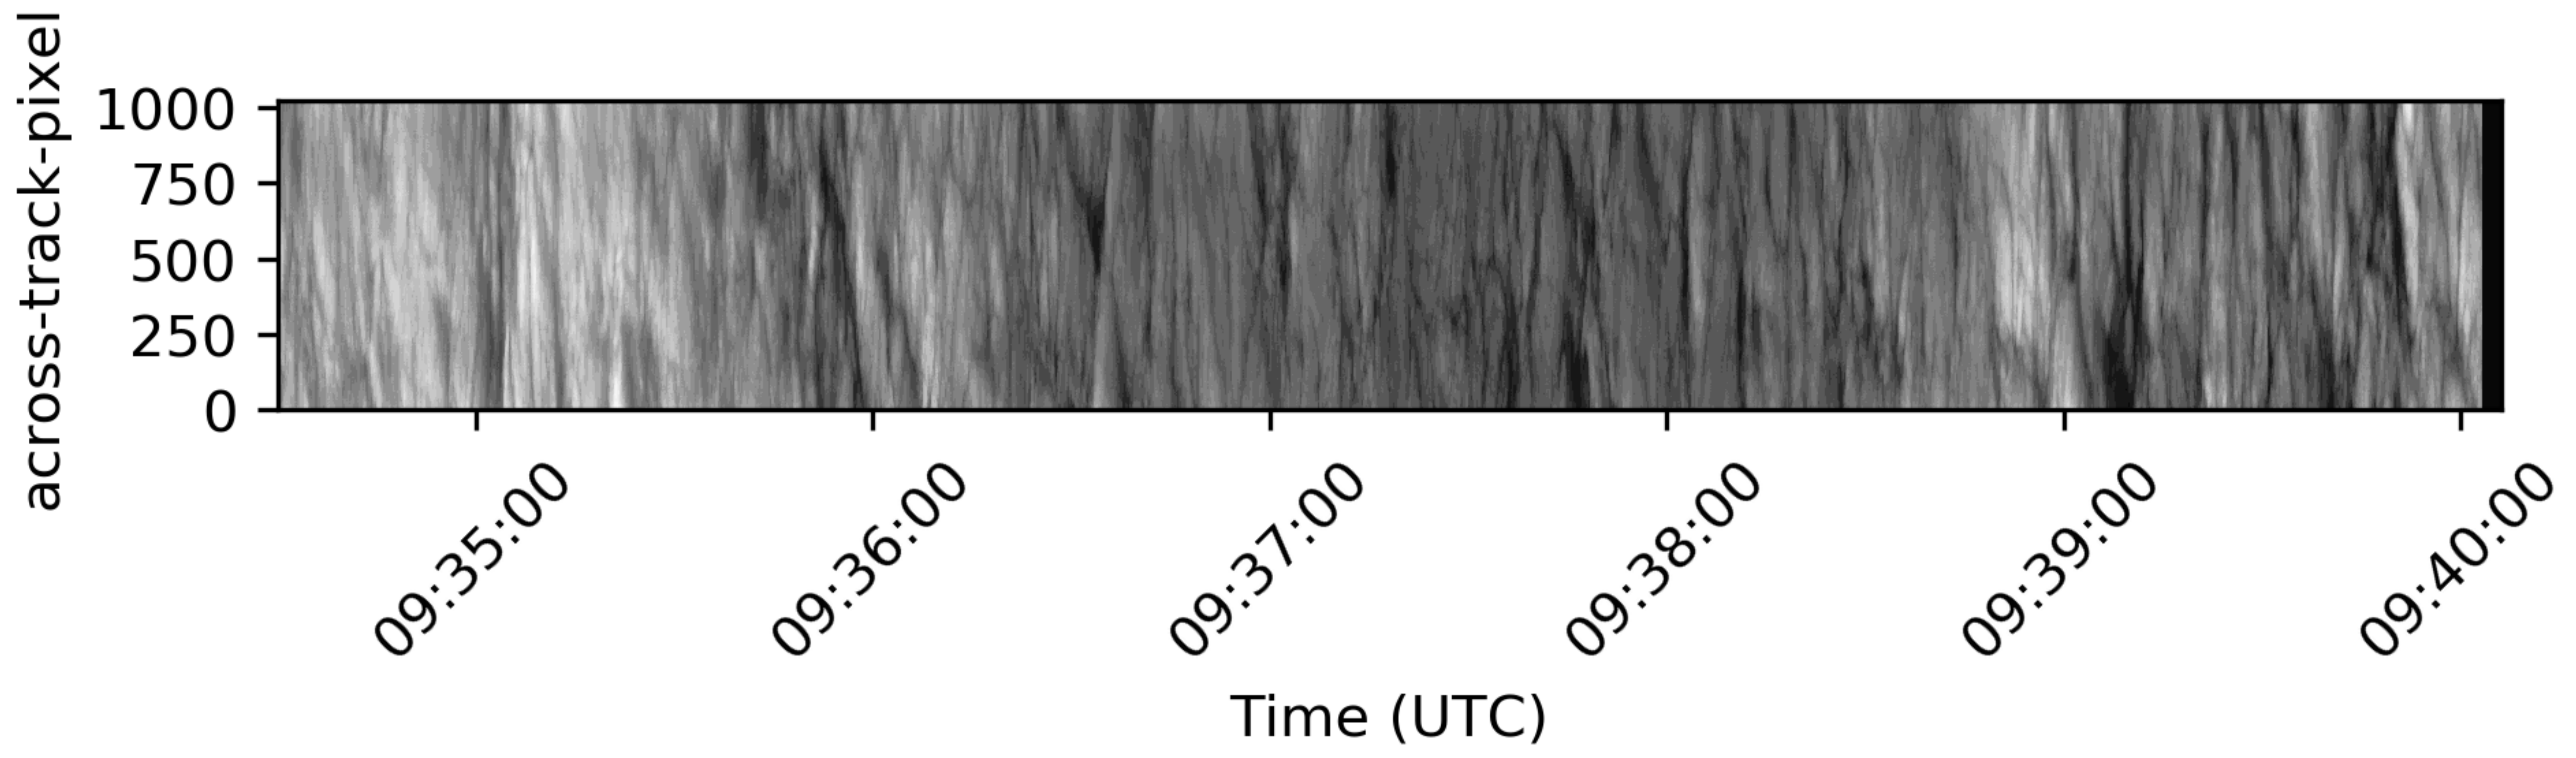
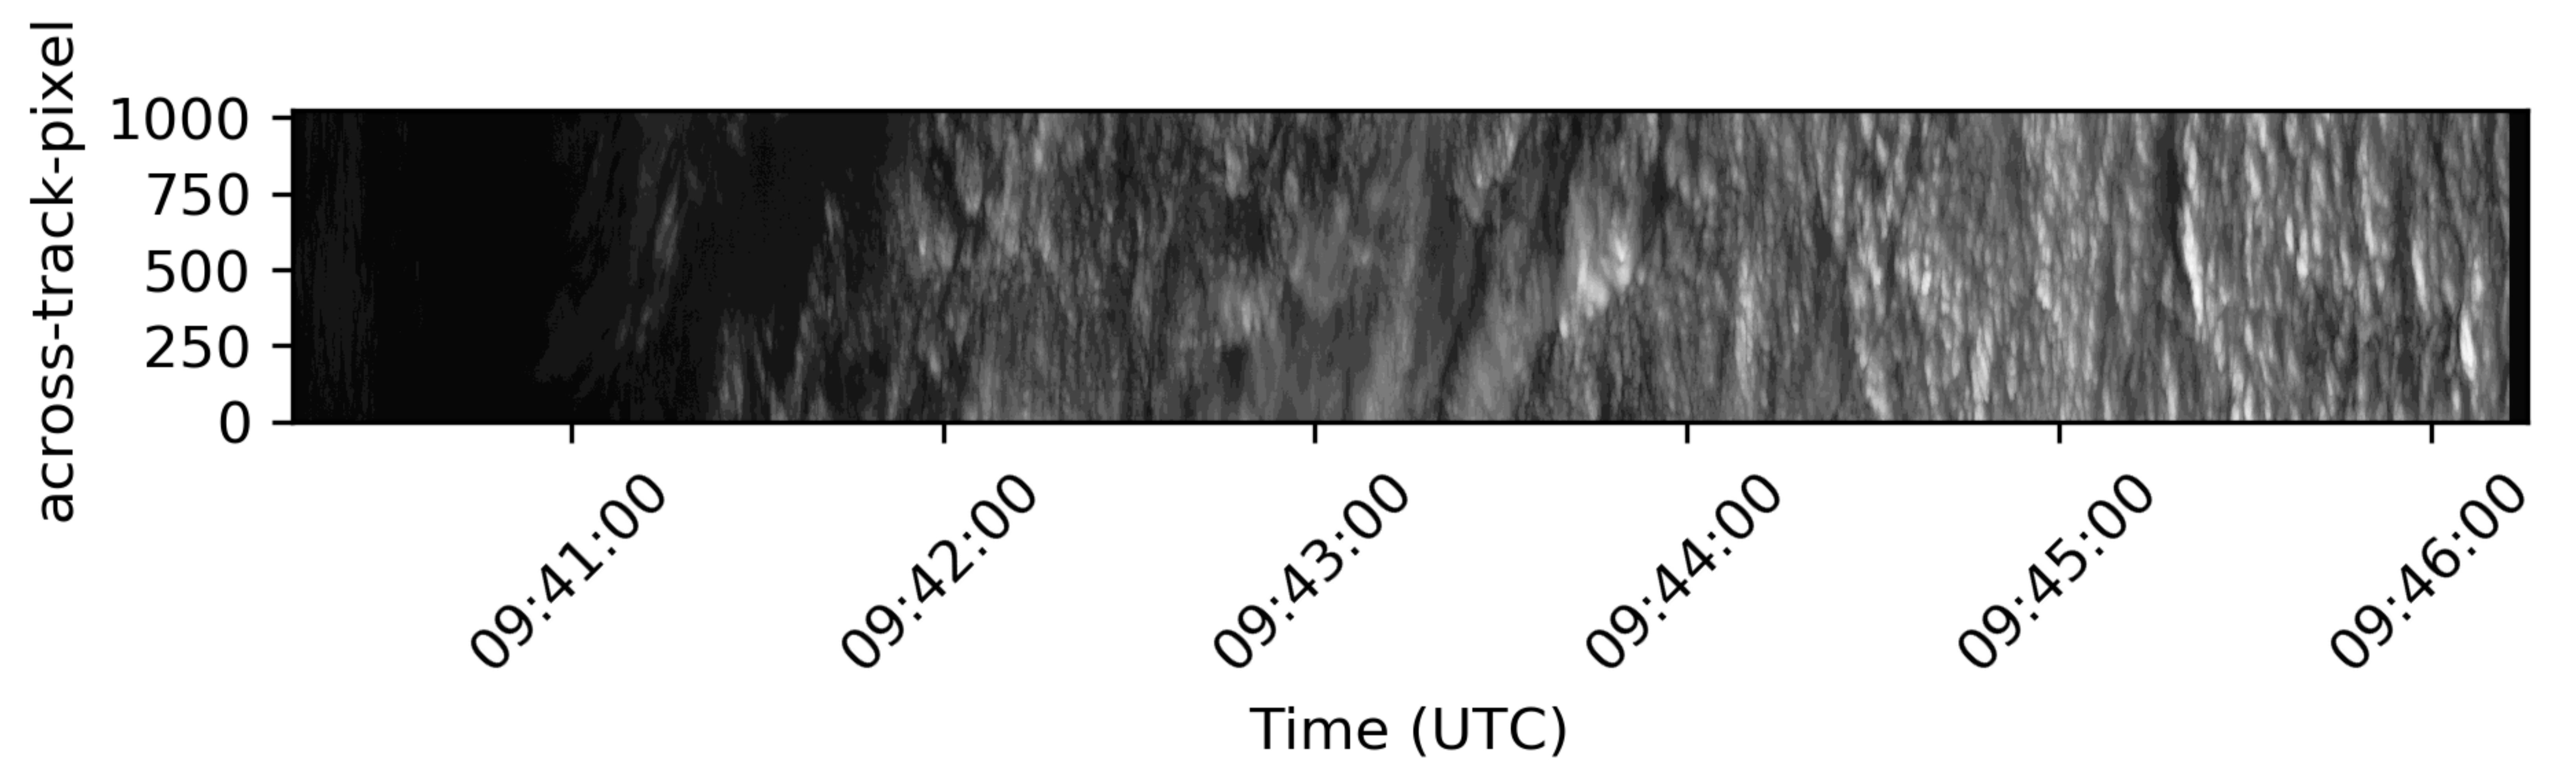
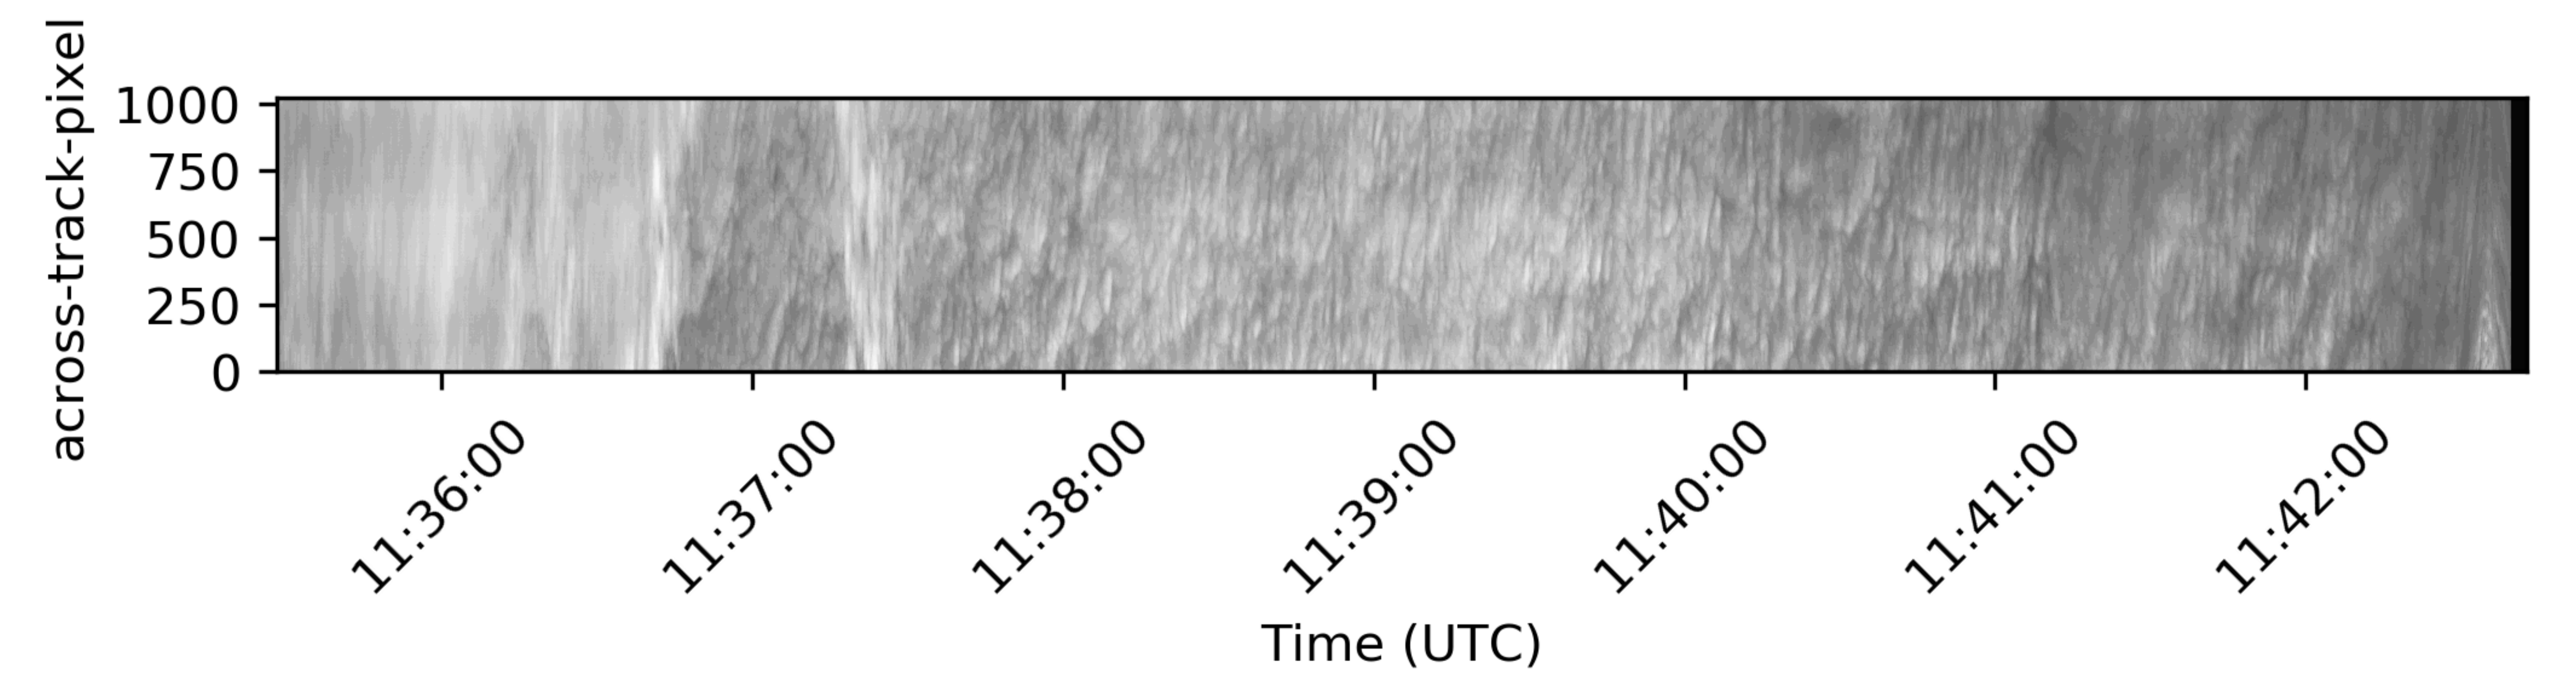
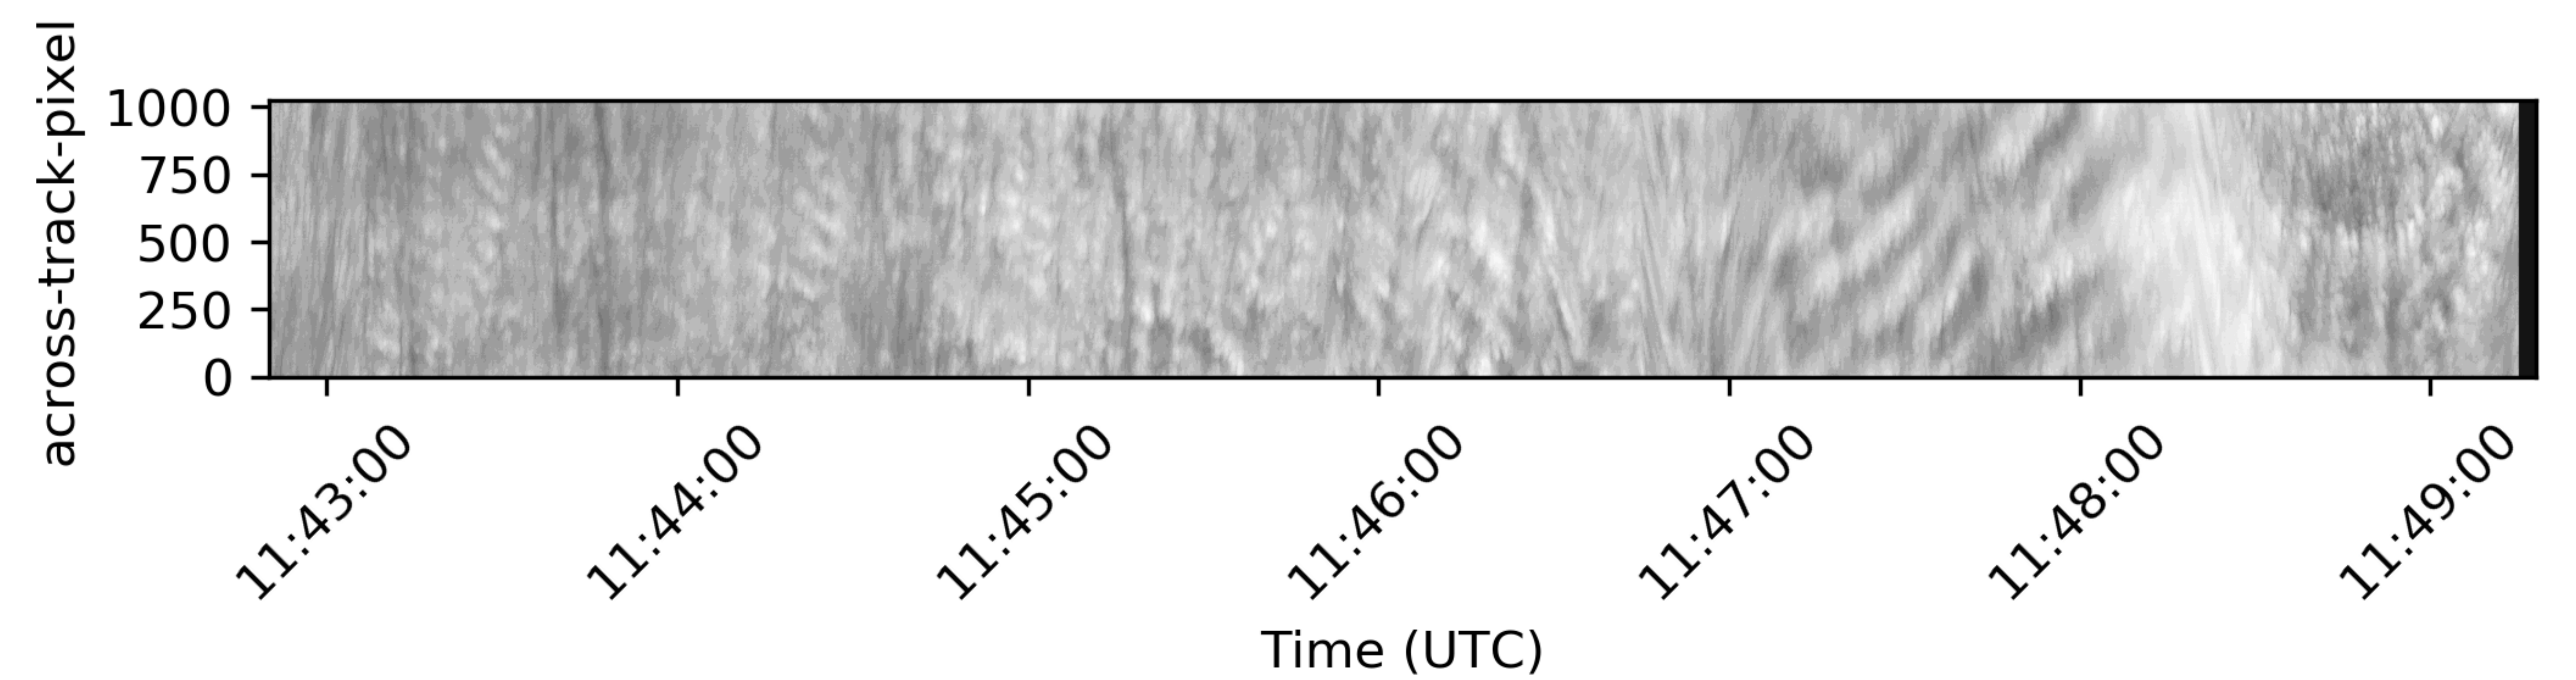
Quicklook Flight 09, 10.09.2020

EAGLE (Spectral imager)

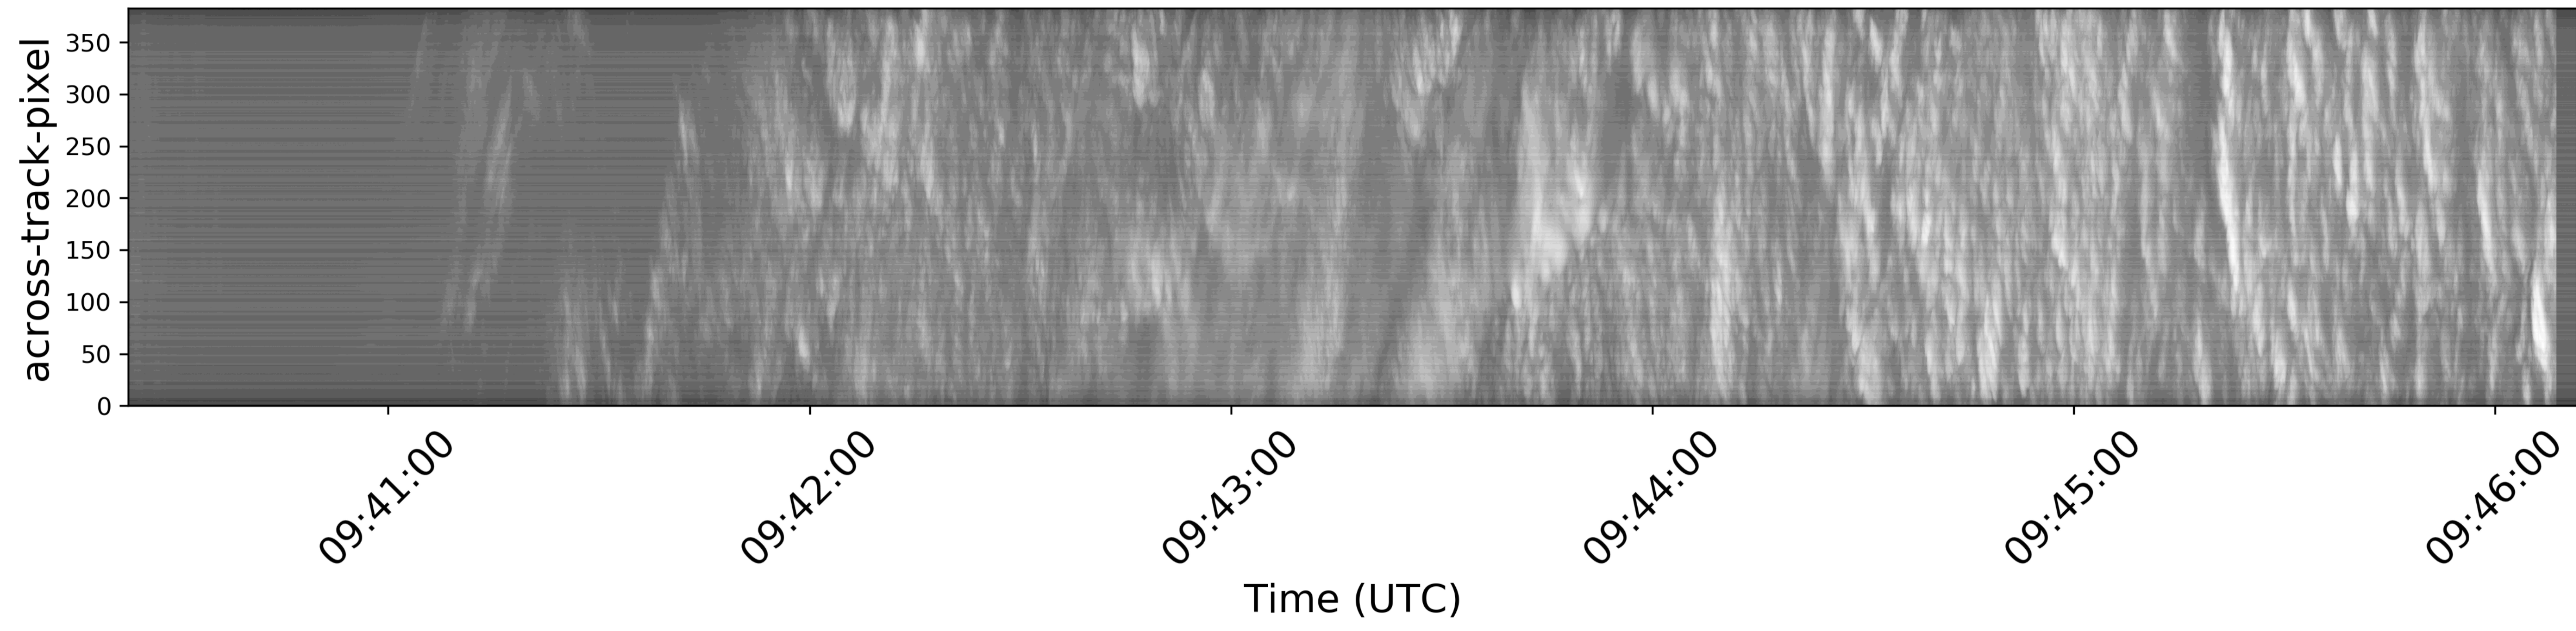
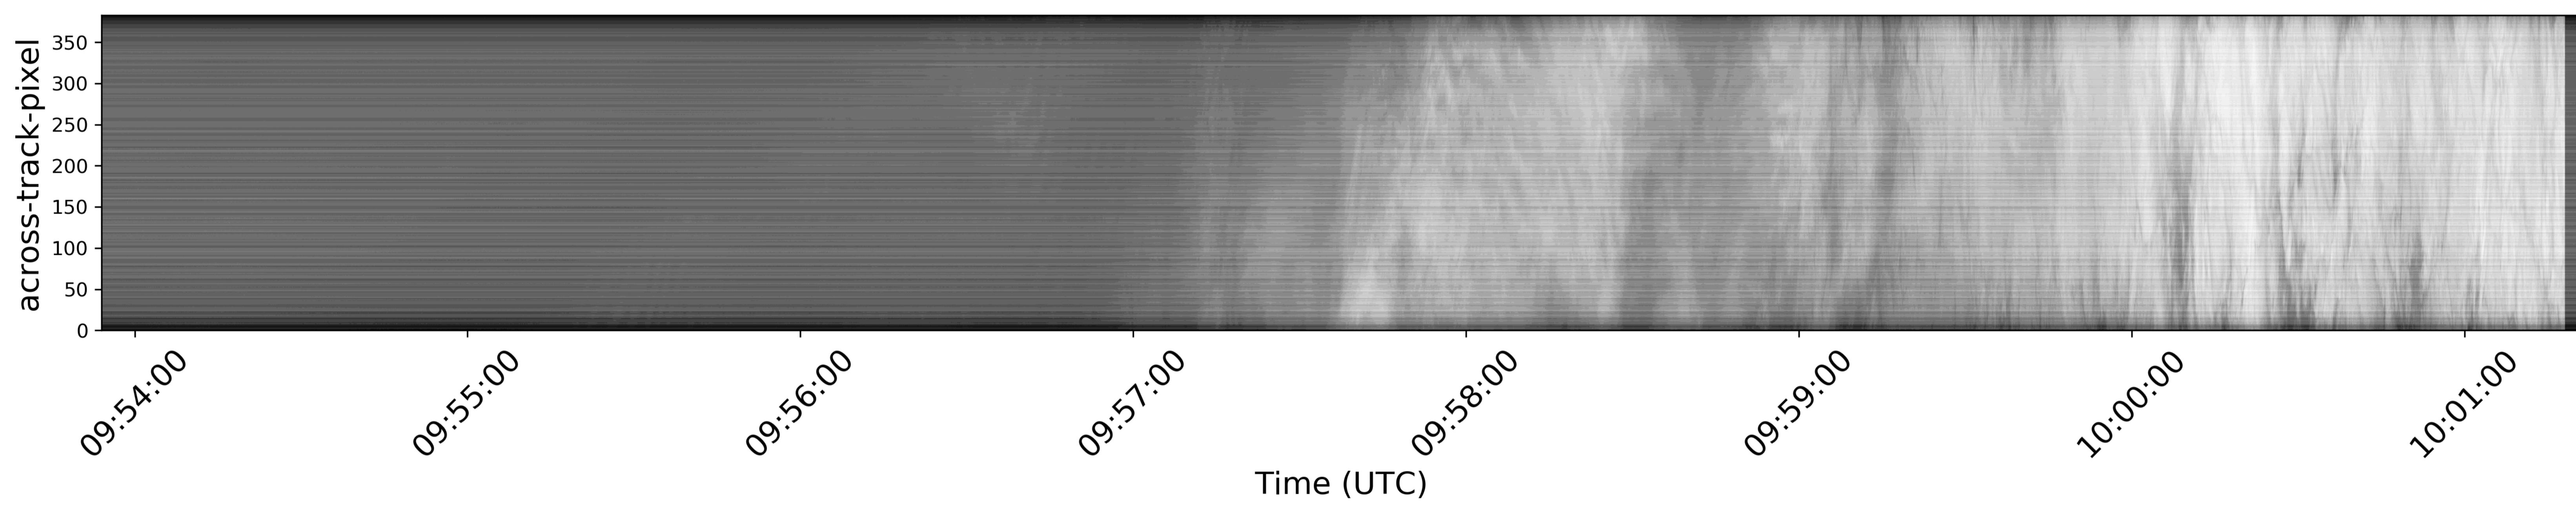
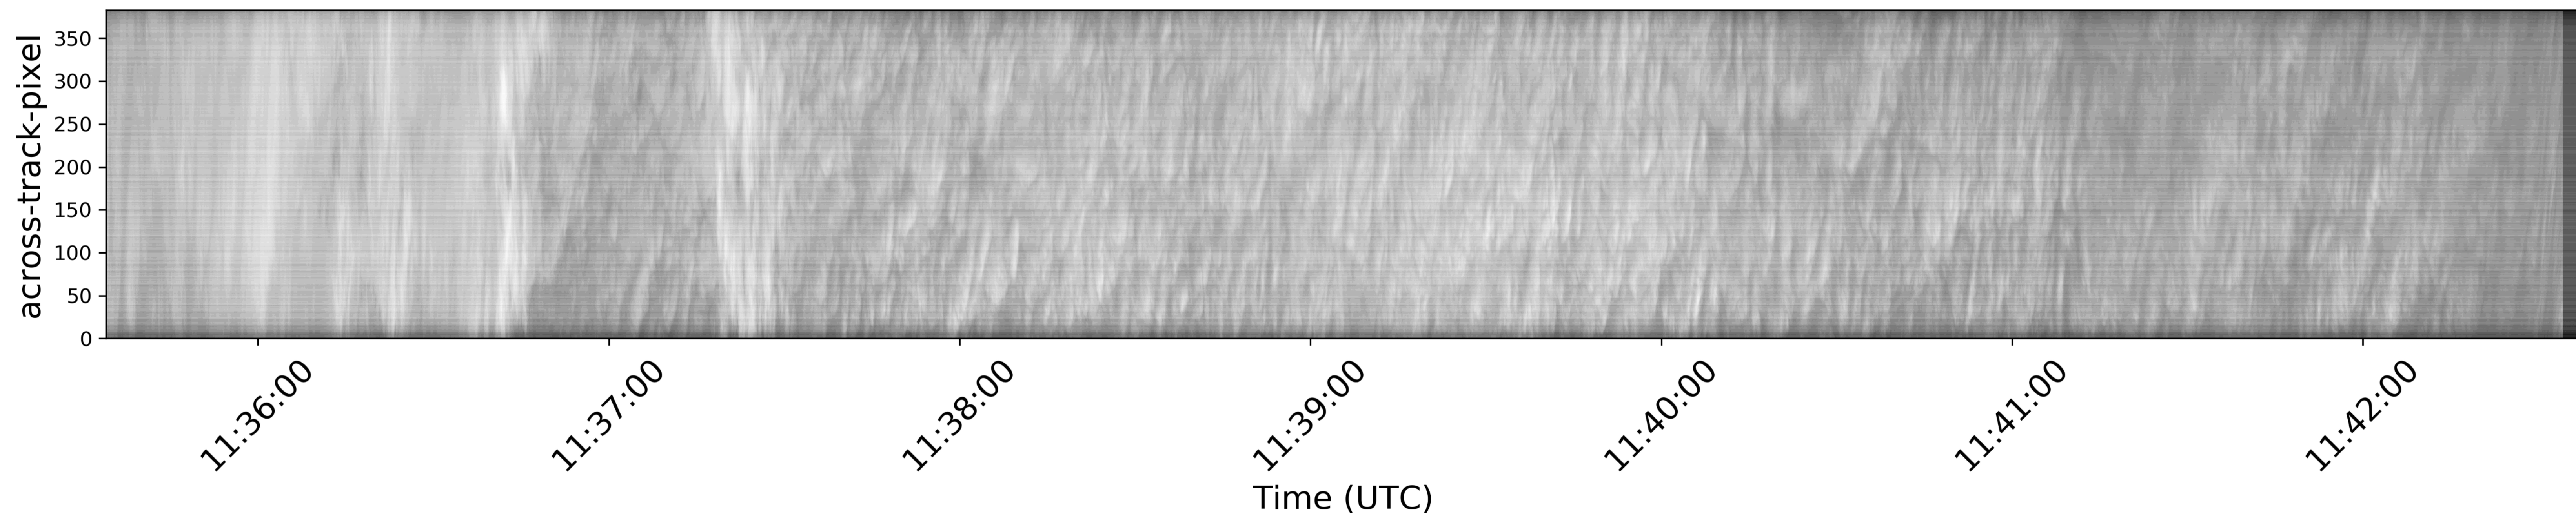
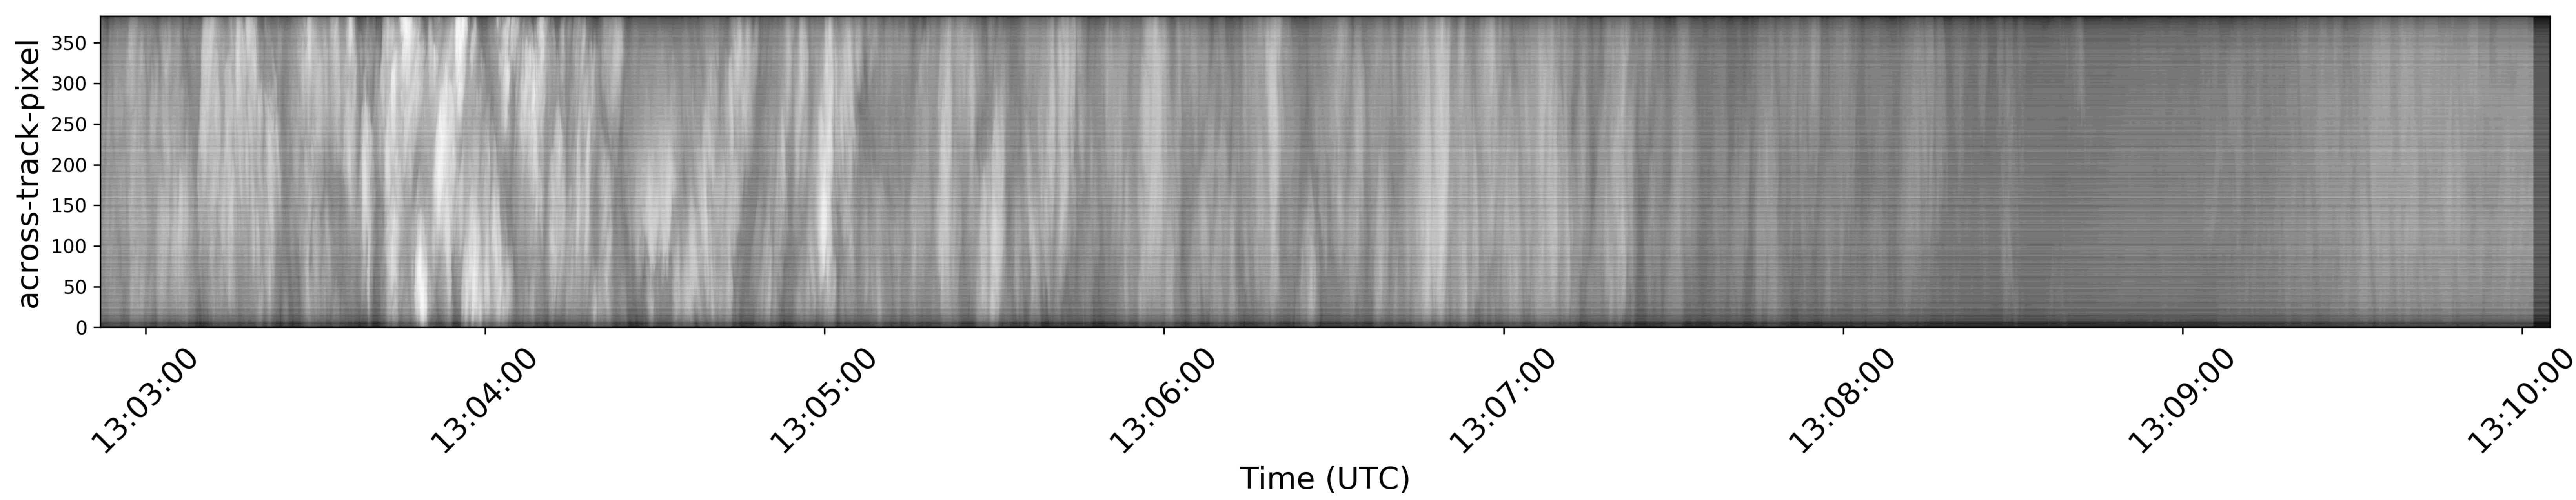
HAWK (Spectral imager)
