HALO-(AC)³ – 2022/04/08 – HALO research flight #15

Objectives:

- Divergence and vorticity estimates of Polar Low west of Svalbard
- Crossing Polar Low several times to sample characteristics with remote sensing package
- Short scale airmass evolution when cycled around Polar Low (east: ocean, west: sea ice)

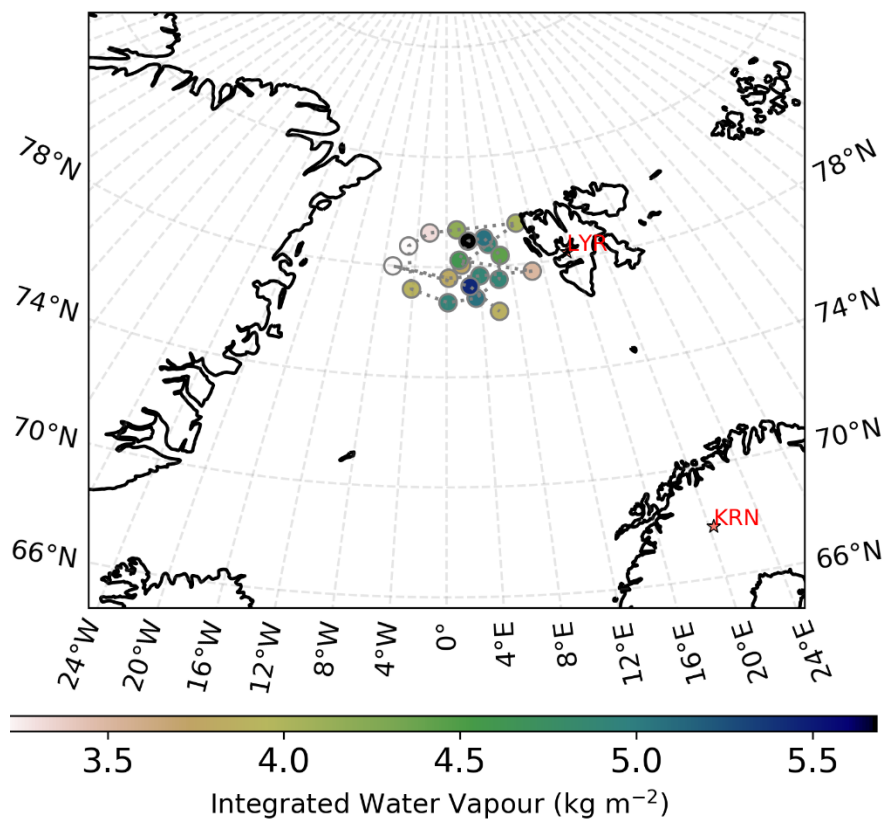
Fig. 19: Integrated water vapour for each dropsonde (except 07).

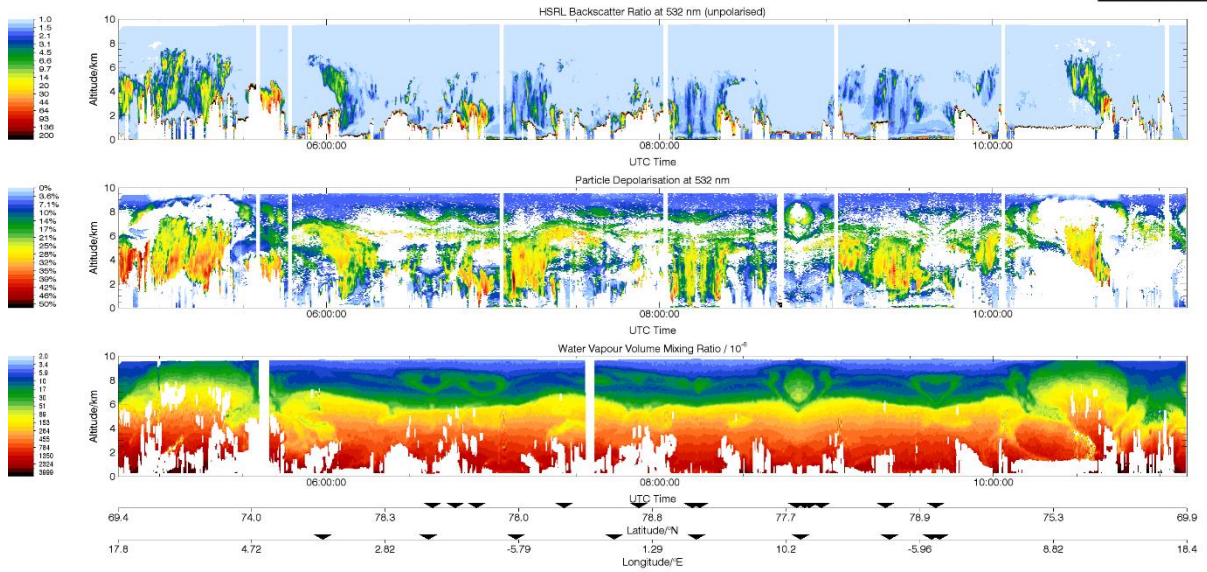
Fig. 20: WALES backscatter ratio, particle depolarization and water vapour mixing ratio.

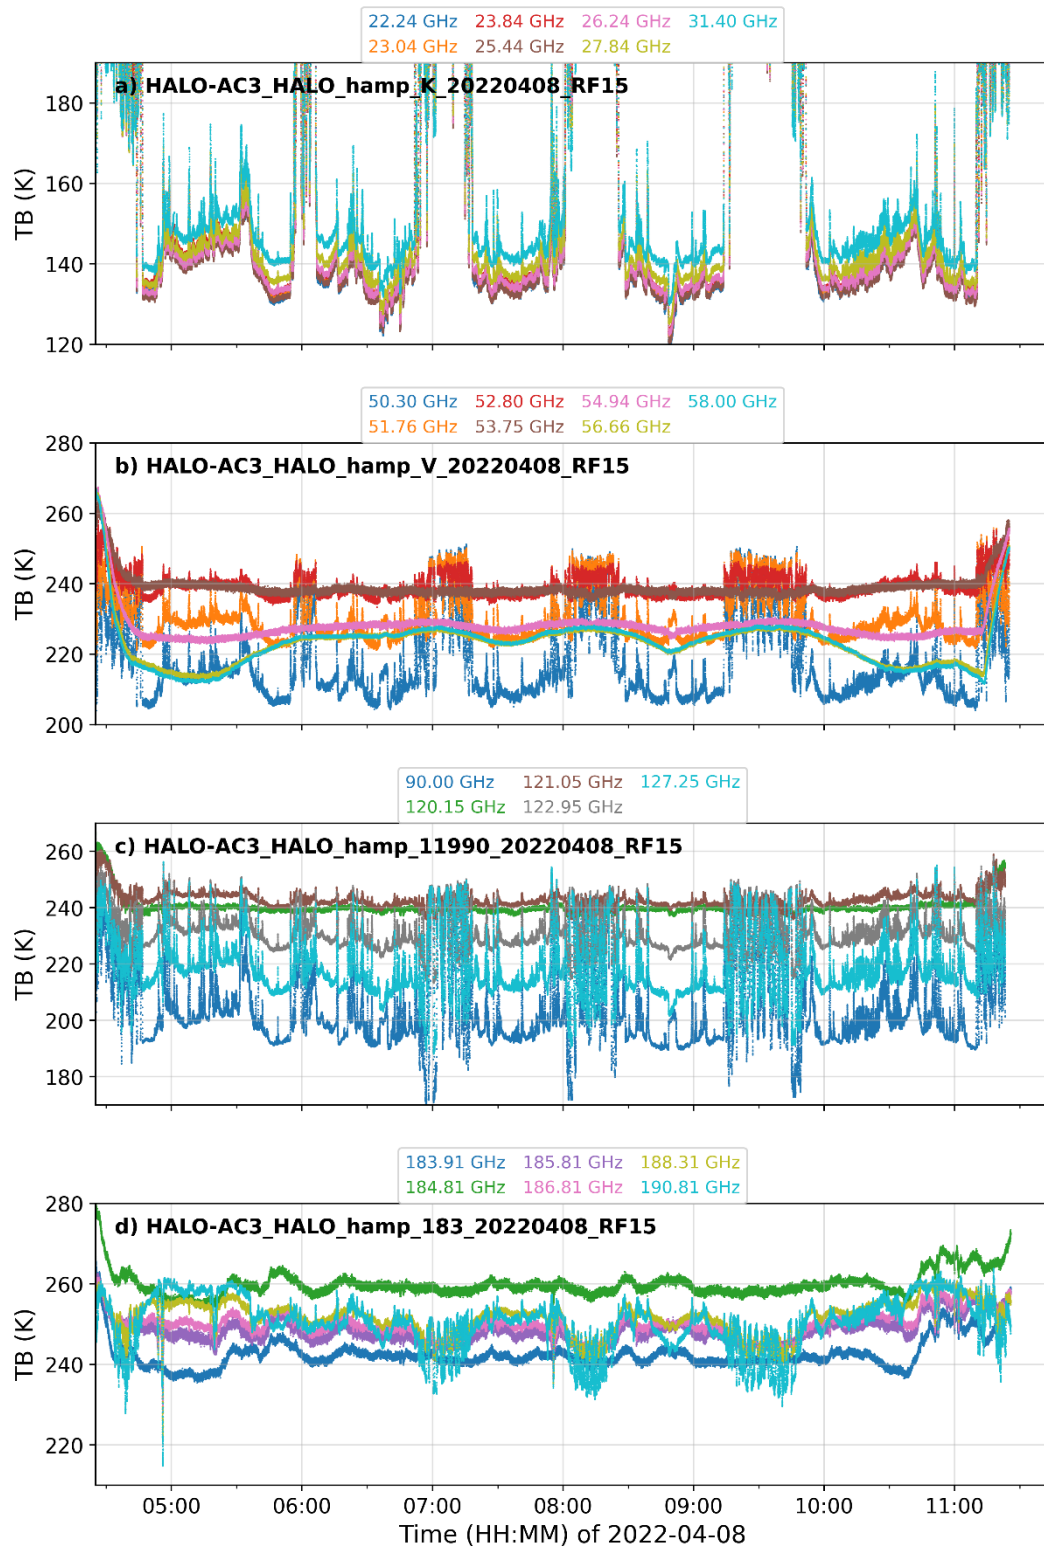
Fig. 22: HAMP microwave radiometers' brightness temperatures.
