HALO-(AC)³ - 2022/04/01 - HALO research flight #12

Objectives:

- Capturing spatial and temporal evolution of cold air outbreak West of Svalbard
- Coordinated flight leg with the Polar 5 and 6
- Capturing low pressure system between Kiruna and Svalbard

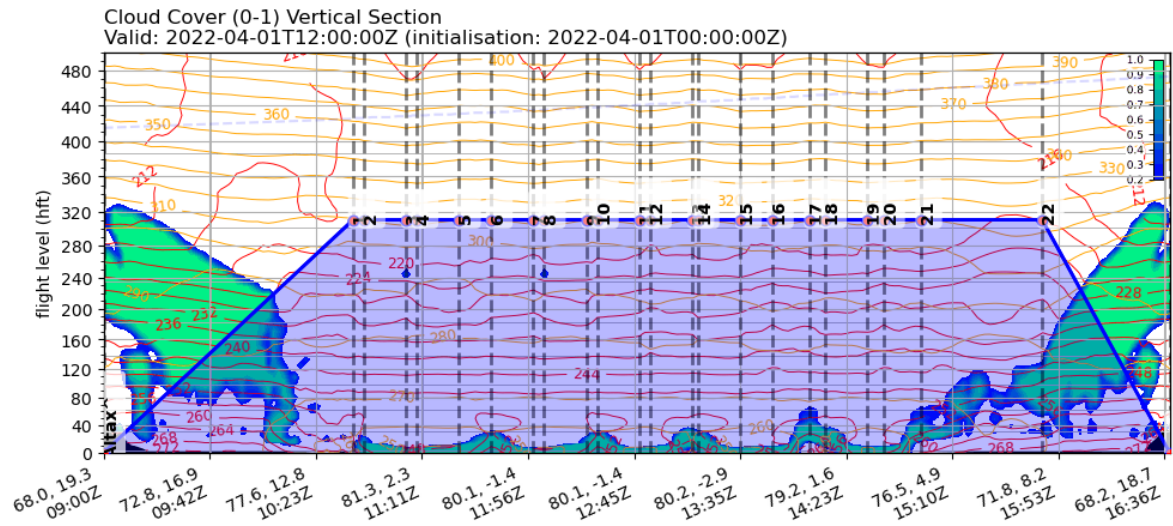
Figure 4: ECMWF: Vertical Cross Section of Cloud Cover

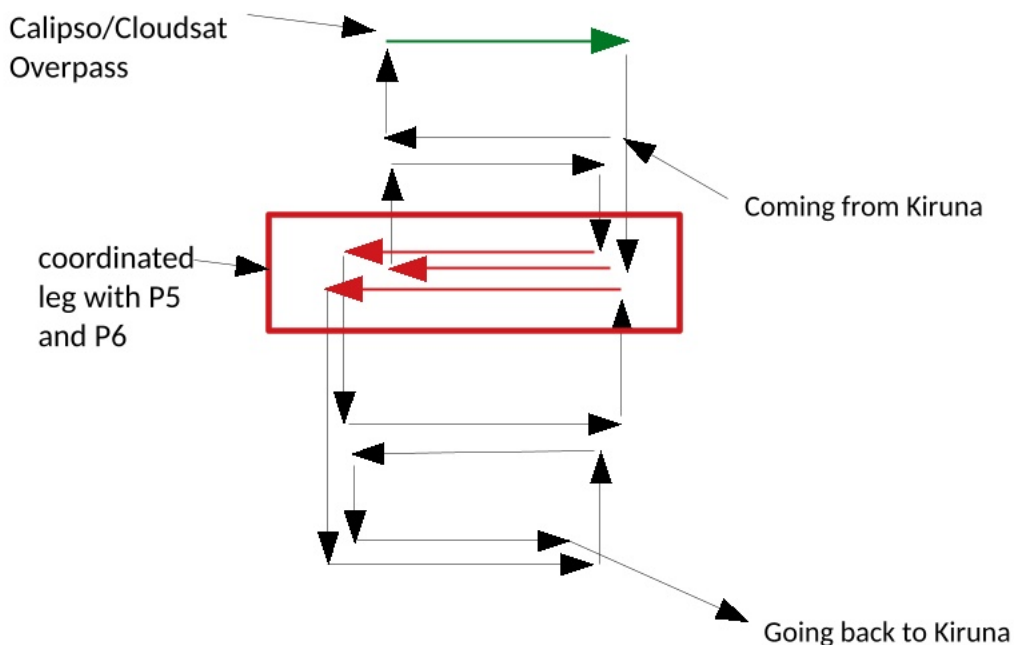
Detailed plan for the CAA region:

The flight plan was arranged to capture the CAA to the West of Svalbard. On the way to Svalbard we were first passing the low pressure system between Norway and Svalbard at FL 400. As a cloud-free area near Ny-Ålesund was predicted, we planned to do the radar calibration pattern and launch one dropsonde in this clearsky region. The forecast was correct and we were able to carry out this plan. As soon as we entered the main measurement region, we were descending to FL 310. In this region five legs perpendicular to the north-easterly flow were carried out:

- Leg 1 was located above the sea ice and was flown only once. The Cloudsat satellite was overpassing us at almost the same time (at about 09:43 UTC). We entered the leg at 09:45 UTC and left it at 10:01 UTC.
- Leg 2 was mainly also over sea ice, but approaching the sea ice edge. This leg was flown two times.
- Leg 3 was a coordinated leg with the Polar aircraft. The Polar aircraft were flying on a part of this leg back and forth for the whole flight. After their first leg, they decided to shorten the leg a bit, as there were no clouds over the sea ice. We had three direct overpasses: The first one at 10:22 UTC, the second at 11:17 UTC and the third at 12:15 UTC. Half of our leg was over sea ice and half of it was over ocean. The coordination worked very well.
- Leg 4 was mainly over the ocean and was flown two times.
- Leg 5 was mainly over the ocean and was also flown two times.

We nicely captured the cloud streets forming just at the sea ice edge. The clouds were low level clouds (as predicted). The forecast has also predicted low level clouds above the sea ice which has not occurred. On these five legs we planned to drop 43 Dropsondes to calculate the divergence pattern of the different regions (ice, ocean, sea ice edge, North vs. South). 5 of the sondes were not working correctly, which is why we dropped 3 replacement sondes.

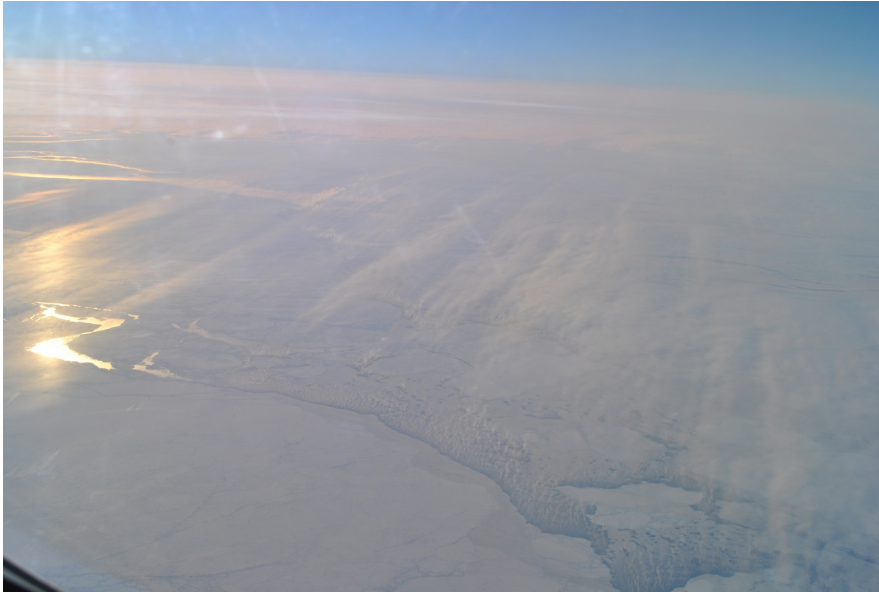
Figure 11: Camera: 10:42:36 UTC. Clouds forming above sea ice leads

10:47 UTC: Thin streaks of condensed vapor hovering over sea ice leads

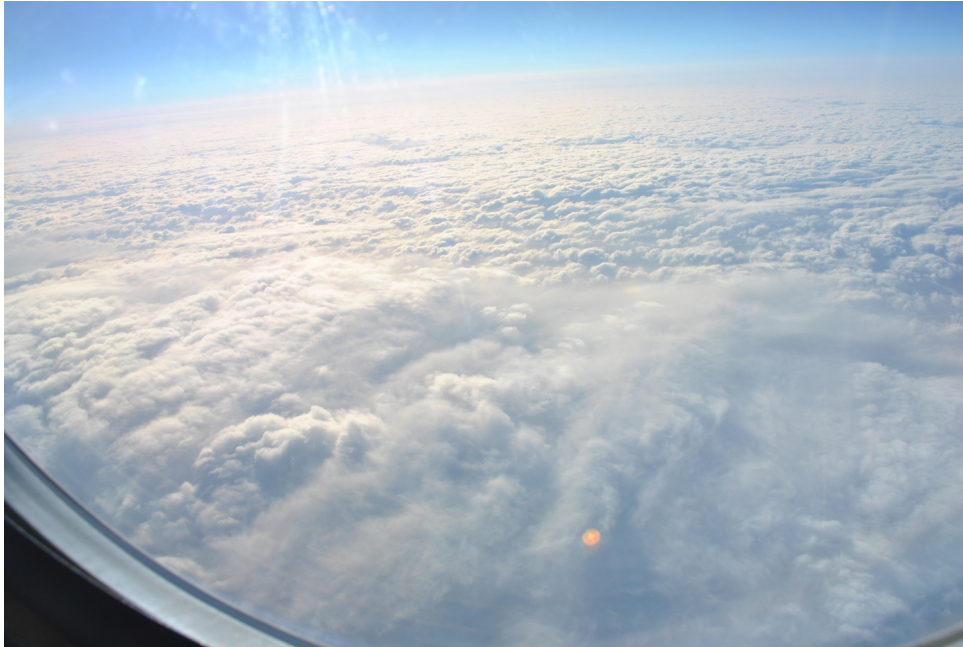
Figure 14: Camera: 14:23:17 UTC. Higher clouds.
