MOSAiC-ACA Flight #04 – Polar 5 – 2020/08/31

Objectives:

Joint Polar 5 and Polar 6 operation close to Longyearbyen and test flight for Polar 5 instruments (nose boom calibration).

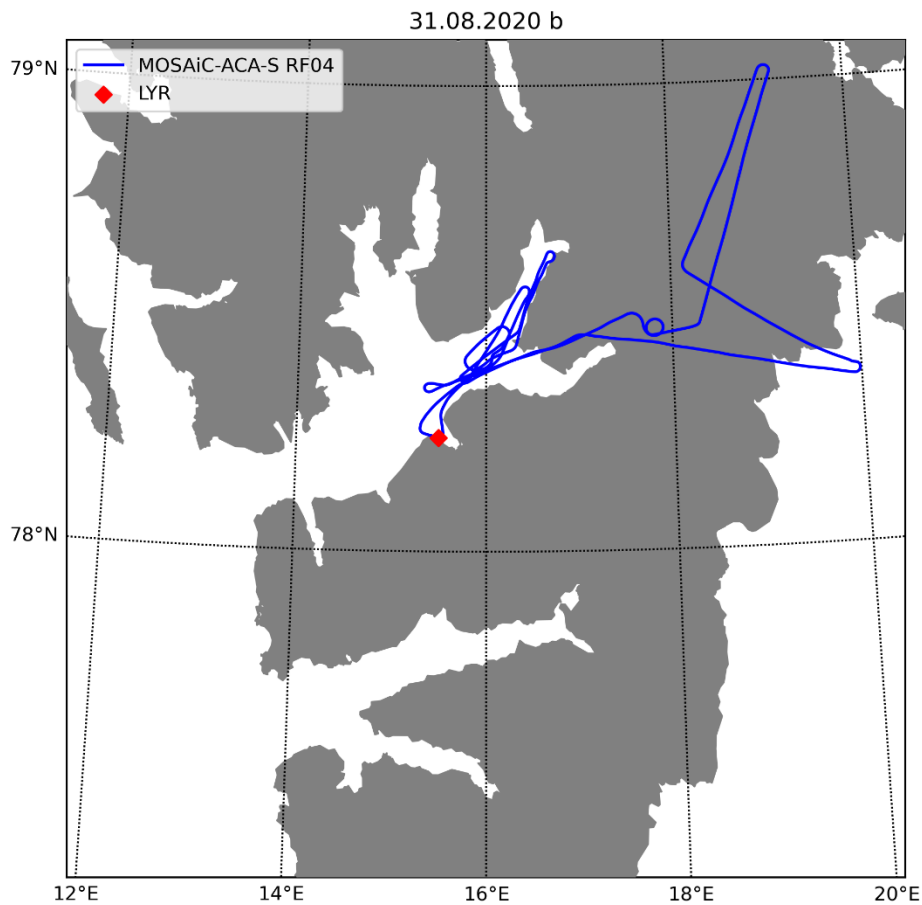
Fig. S5.1: Flight Track of Polar 5

with fixed waypoints. Polar 5 used a constant heading, east-west and north-south. Therefore, the flight track was affected by the southerly winds and the forth and reverse legs did not match perfectly. However, we could finish both calibration legs without flying in clouds. Some clouds could be sampled by the remote sensing instruments, although, over the island the cloud situation was rather complex. Afterwards, we continued with the instruments tests and returned to the airport.

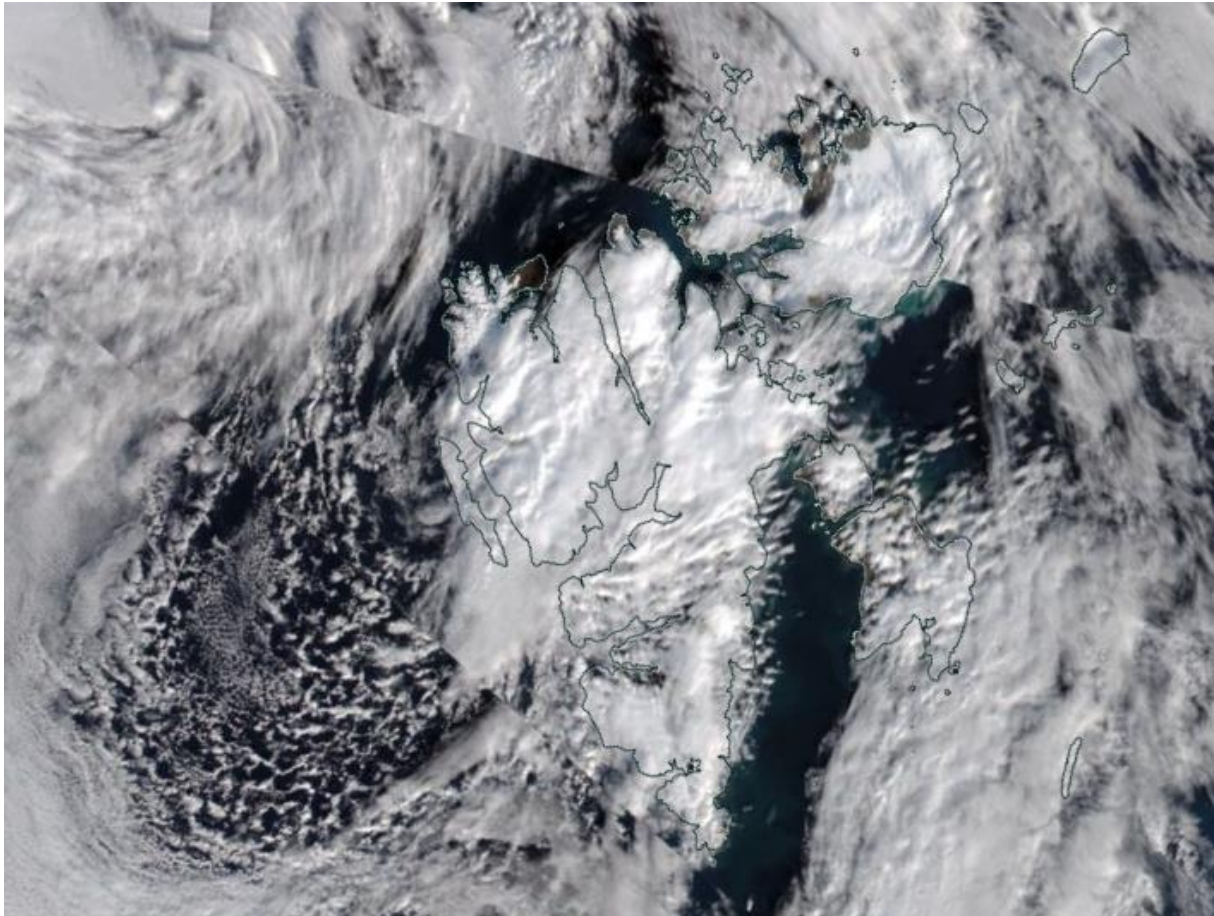
A low pressure was located close to the north western tip of Svalbard. This position was very stable and led to a southerly flow over Svalbard associated with a low and mid-level cloud layers present over the Isfjord. West of Svalbard only low clouds were expected as visible on the satellite image below. This was the area we aimed to fly for testing the remote sensing instruments and calibrating the nose boom.

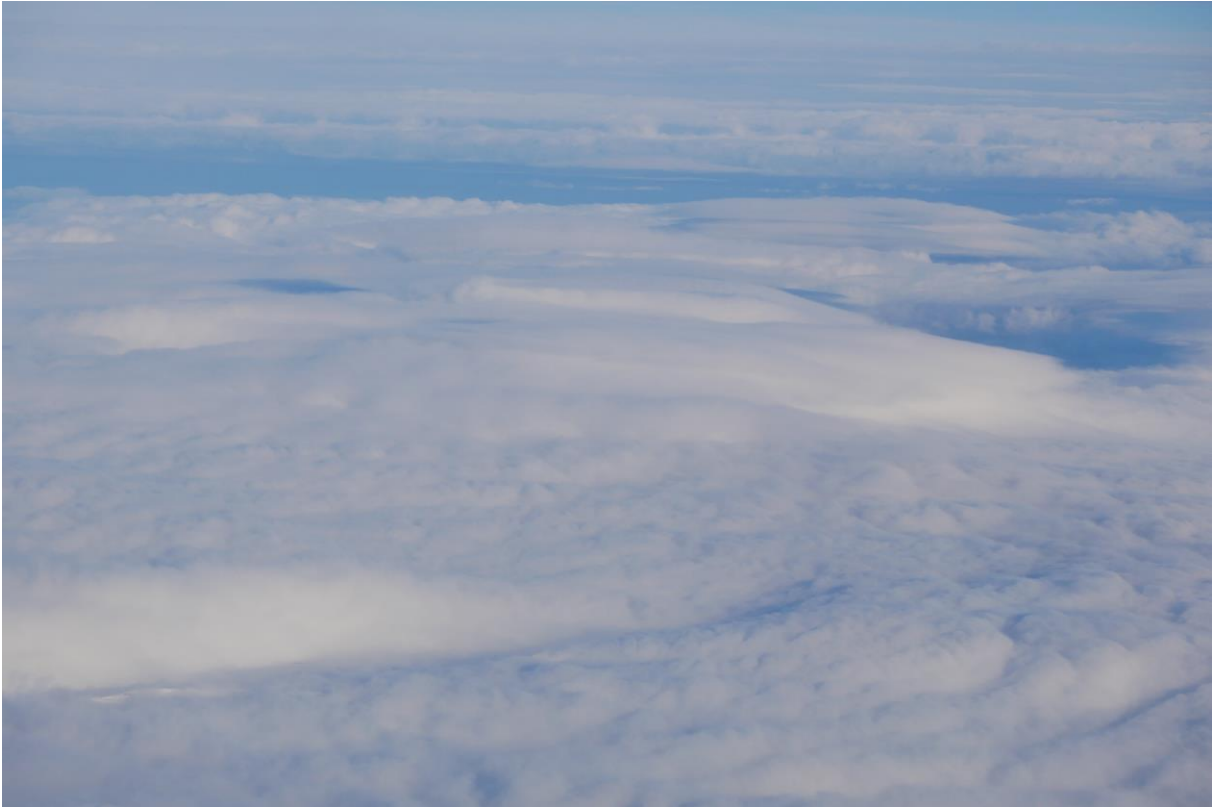
14:19 UTC Complex cloud structure passed during the horizontal calibration legs.

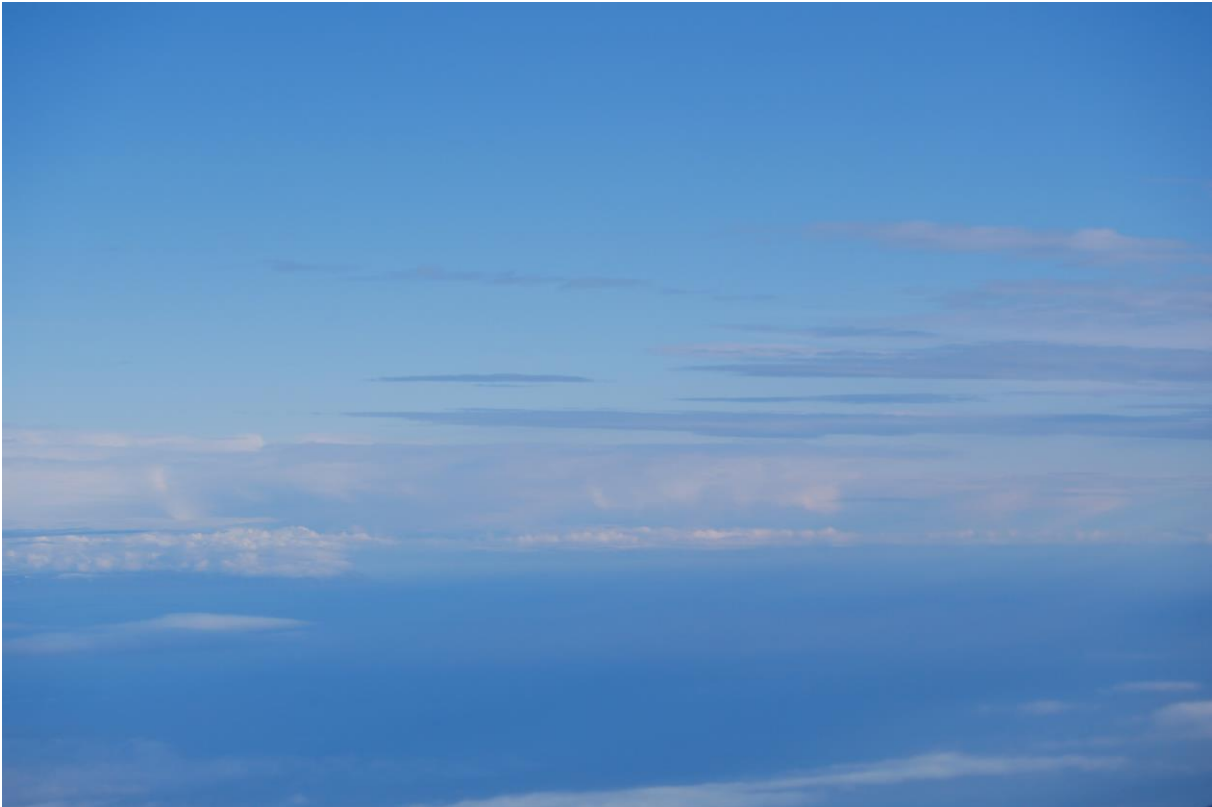
14:19 UTC Almost cloud free above Polar 5 but some inhomogeneous mid-level clouds south of the flight track.
