# AFLUX Flight #11–13 September 2020

## Objectives:

Study differences in the atmospheric structure over sea ice and open ocean

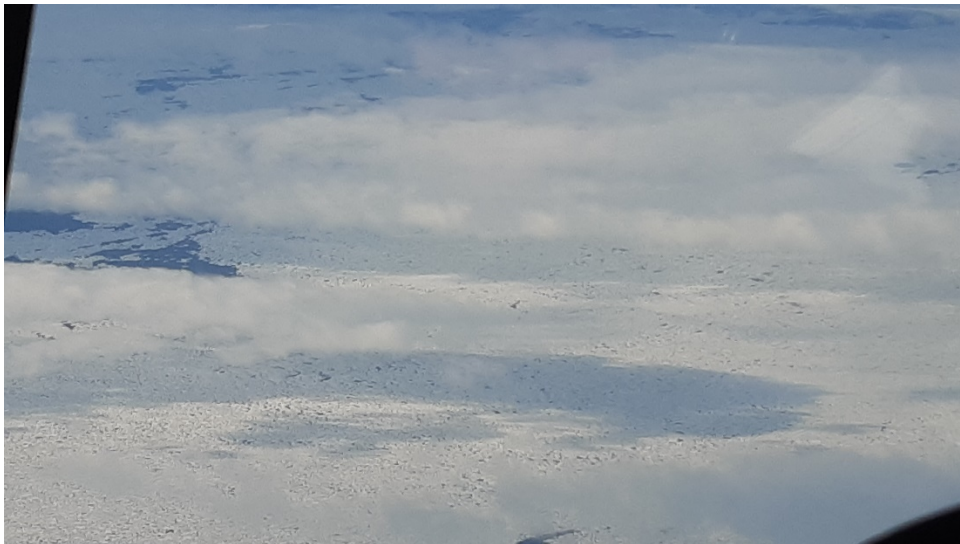
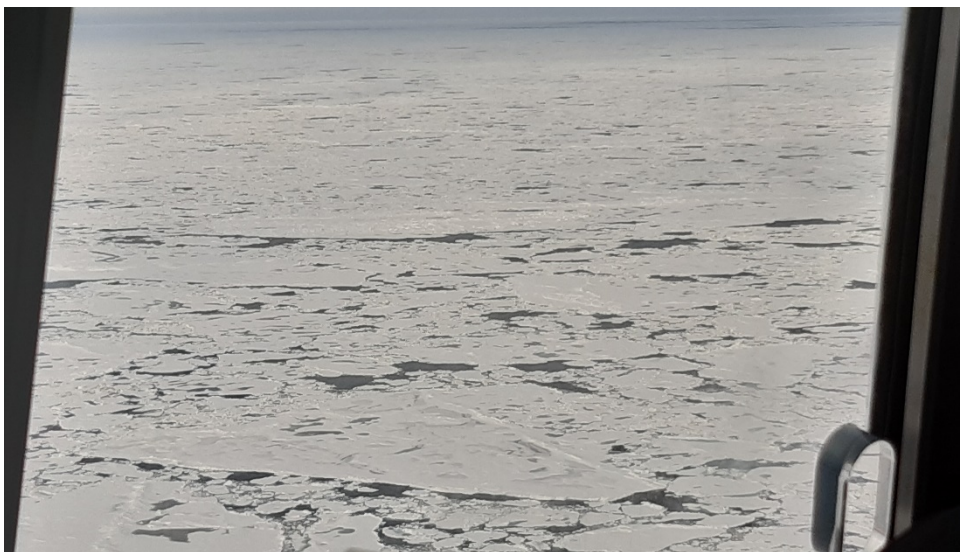
Sea ice conditions at western staircase position

The western staircase was over drifting sea ice floes of about 90 % concentration. The sea ice was visible already from 10.000 ft (see foto below) while we approached the planned staircase position.

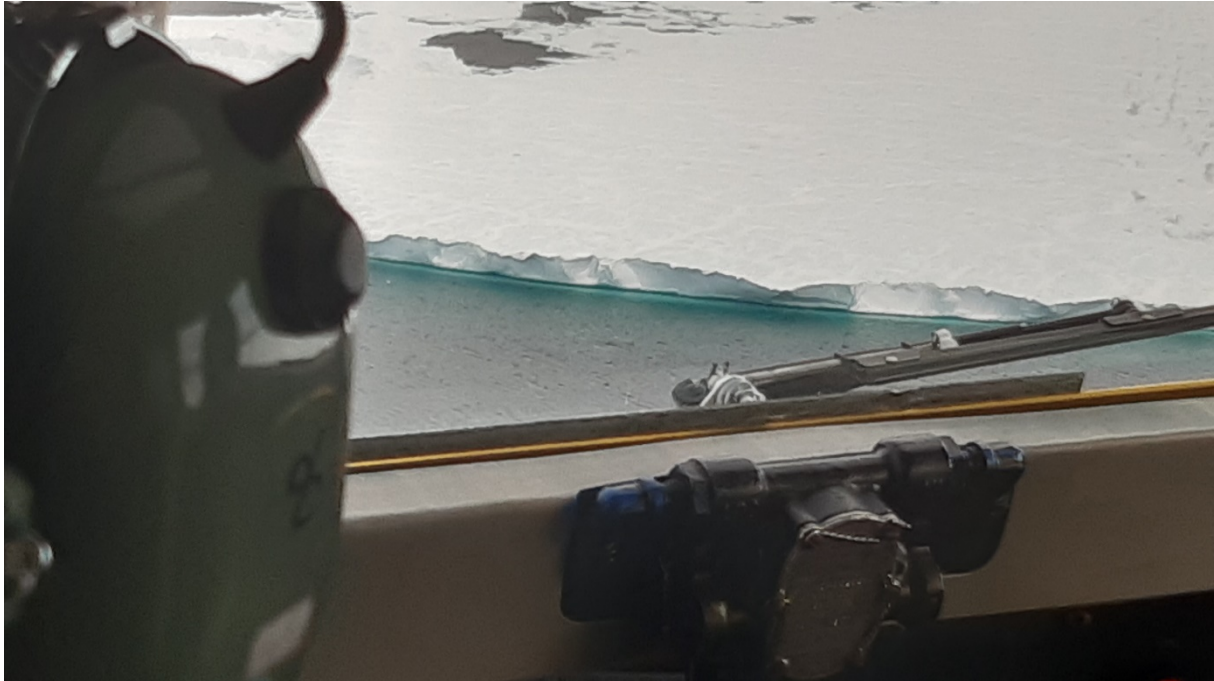
During the transect from the western to the eastern staircase, we crossed some thick floes.

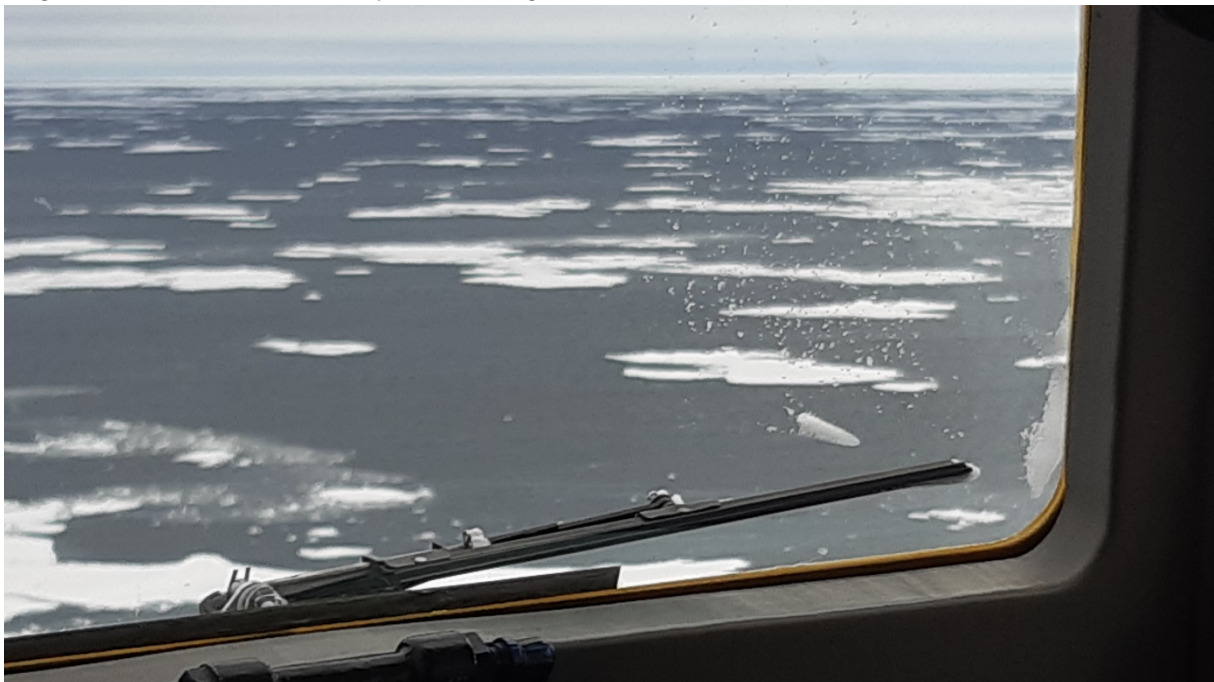
Further to the East, the sea ice cover reduced strongly (photo below) until we reached the ice edge at about 3.5 W with only few drifting floes.

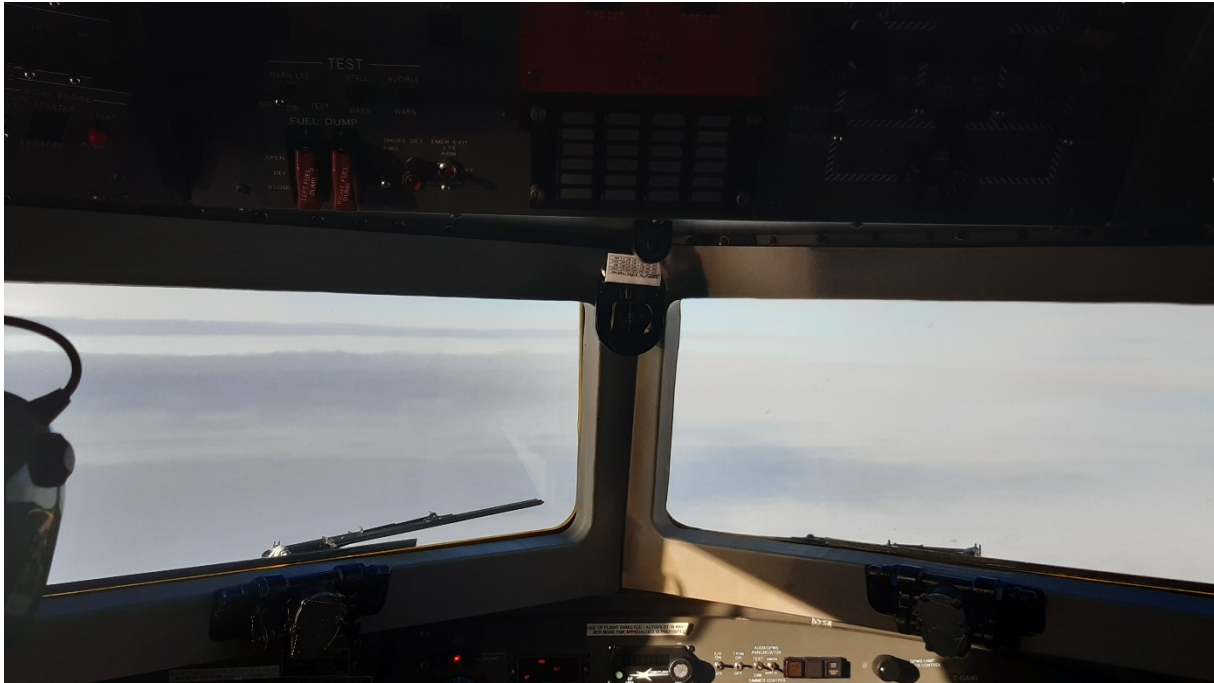
After leaving the western coast of Svalbard we crossed a mid level cloud layer with tops around 13.000 ft so that we had to ascend to 13.500 ft. However, although their vertical extent was high these clouds were most often thin, typically as shown in the photo below.

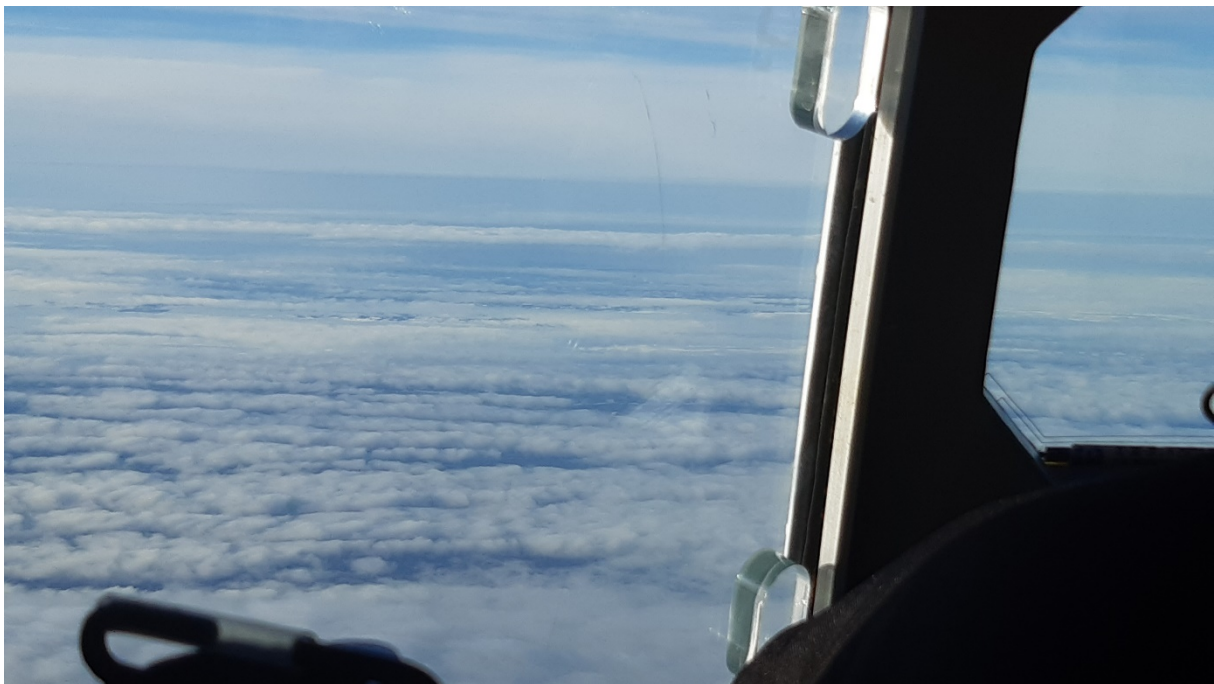
After crossing the sea ice edge high clouds disappeared but occurred again when we reached the western staircase position. The photo below shows also that roll-type clouds occurred over the sea ice covered region.

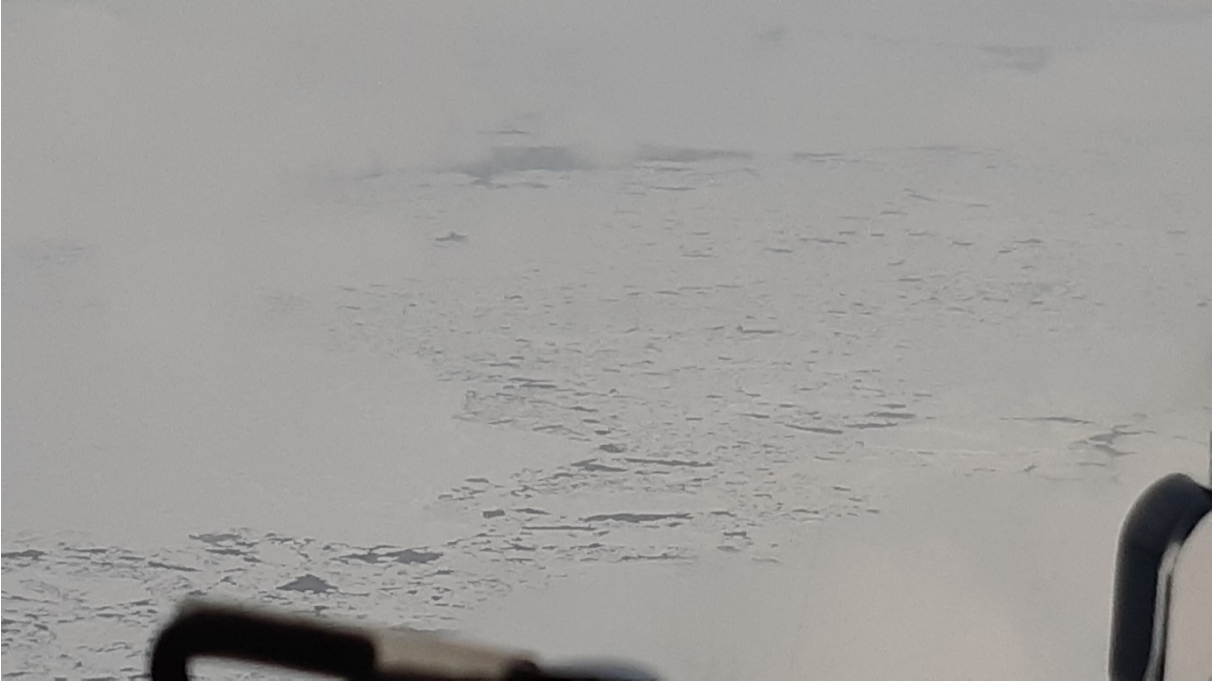
During the horizontal low level legs cloud conditions were strongly inhomogeneous. Some clouds reached the surface as shown below (probably due to a lead).

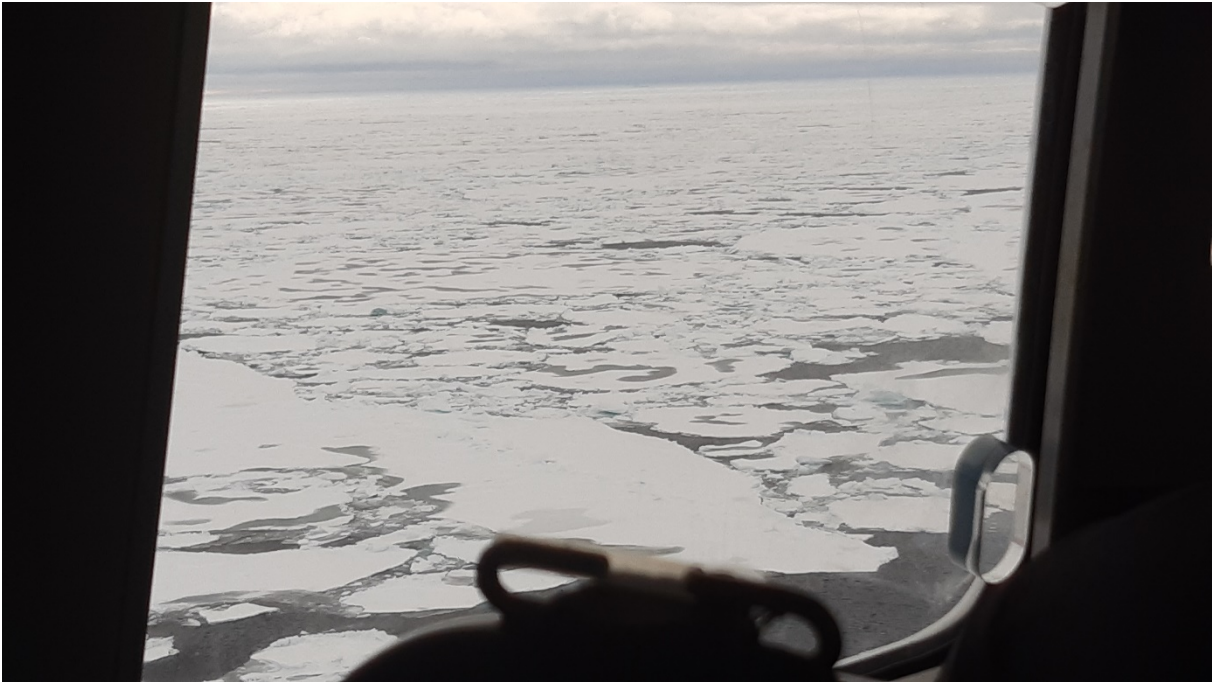
Some other parts of the legs were clearly outside clouds (especially the lowest leg as shown below).

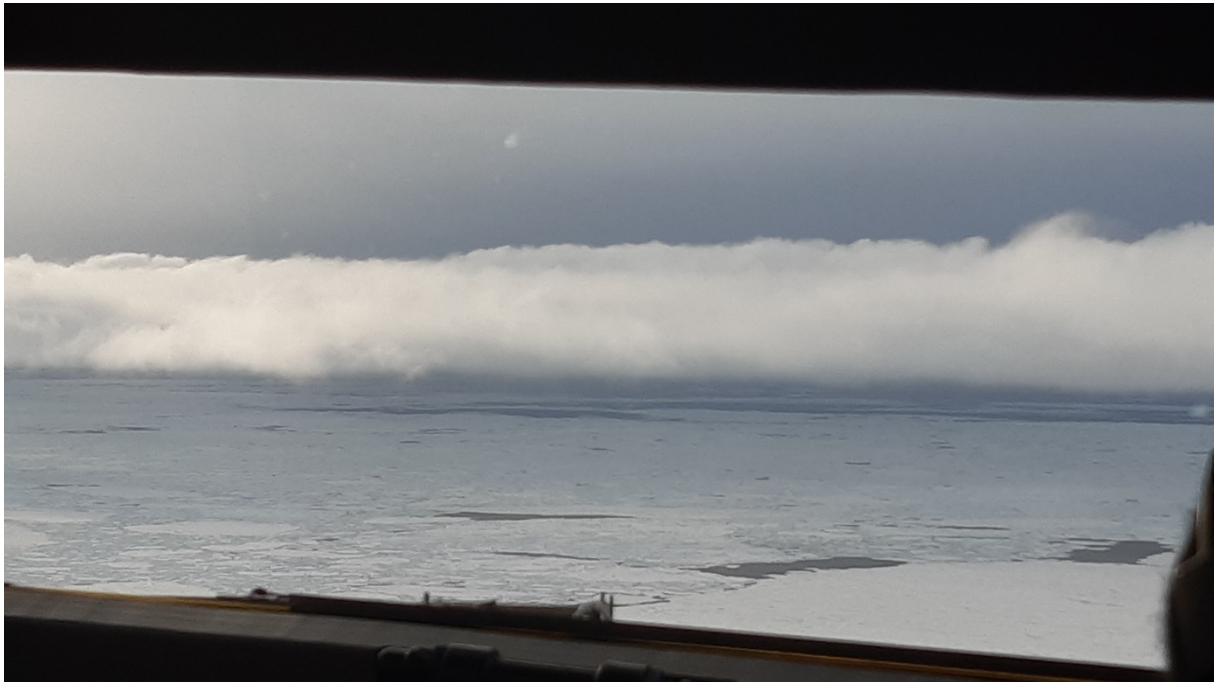
Despite some surface based clouds the main cloud base was near 850 ft where one of the legs has been flown. The tops were near 1700 ft, but due to the roll structure (see also to Figure below), parts of all cloud legs have also been outside of the clouds.

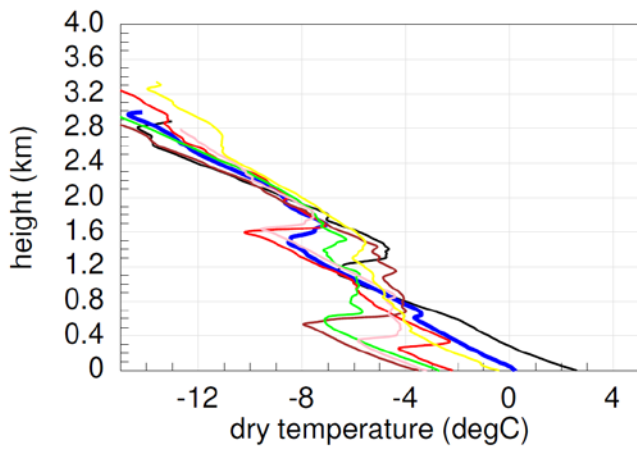
**Dropsondes**

Four drop sondes have been thrown on the way towards West and 3 ones on the way back (see positions in the Figures for quicklooks).
