HALO-(AC)³ – 2022/04/05 – POLAR 5 research flight 11

- Wing-by-wing flight maneuver for noseboom intercomparison
- Collocated flight with POLAR 6 to get data for retrieval algorithms
- Sampling the cloud structure between the lee of Svalbard and the Arctic ice

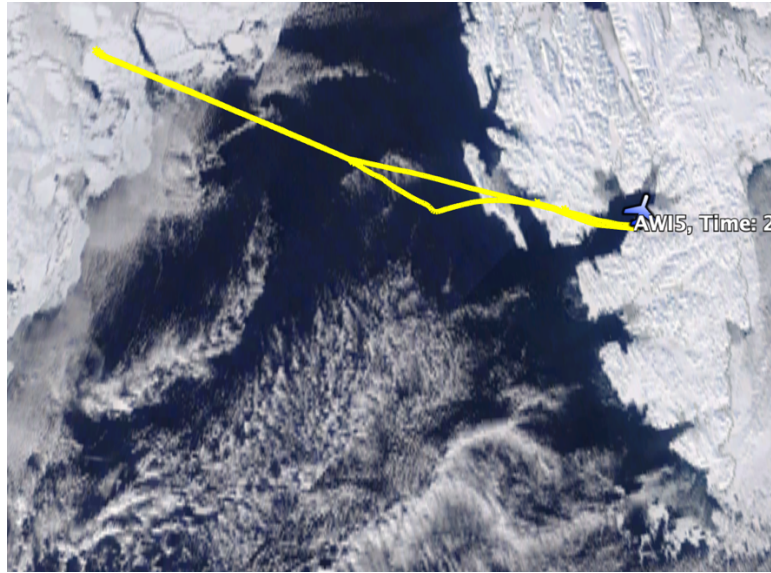
Fig. 2: Flight track with MODIS satellite image (from 05.04.2022).

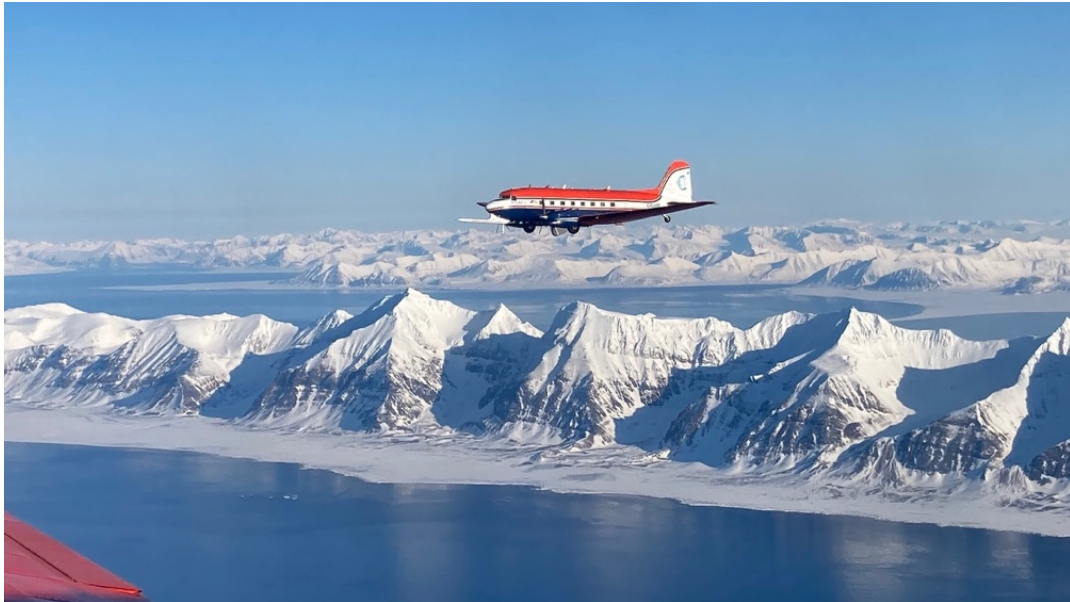
Fig. 6: Photograph of the POLAR 5, taken from the POLAR 6, during the wing-by-wing flight (courtesy J. Schneider).

On the way towards WP1, we had clear sky conditions and could perform the wing-by-wing maneuver for the noseboom intercomparison (see Fig. 6). These cloud-free conditions, which formed westward of Svalbard, were also expected in the model forecast (see Fig. 4b) and are caused by the lee of the island. On the way to WP2 we didn't see any clouds in the first half of this leg. Closer to the ice edge, cloud streets started to form. Directly over the ice, when we flew at an altitude of 200 ft, no clouds were present above the aircraft (see Fig. 7d). Towards the sea ice edge, clouds started to form again (see Fig. 7f).

All the objectives of this flight (see first page of this report) were achieved. During the ferry to WP1, we flew next to the POLAR 6 to perform the wing-by-wing maneuver for the noseboom intercomparison (see Fig. 6). After that, the POLAR 5 climbed to 10000 ft and reached WP1 on this altitude. On the first leg from WP1 to WP2, we stayed close behind the POLAR 6, which performed in-situ measurements, to collect data for the development of retrieval algorithms. After this leg, the POLAR 5 turned around and flew independently of the POLAR 6 back to WP1 and did there a procedure turn to fly again on the same leg. Ten minutes before reaching WP2 again, we decreased to 200 ft. From WP2 towards the ice edge, we stayed at this altitude, as requested by the Sun photometer operators. After reaching the ice edge, we climbed up to 10000 ft again, and after reaching WP1, we headed back to Longyearbyen. During the whole flight, 10 dropsondes were launched (see locations in Fig. 1). All key instruments worked well, except for the noseboom where not all sensors were working correctly.

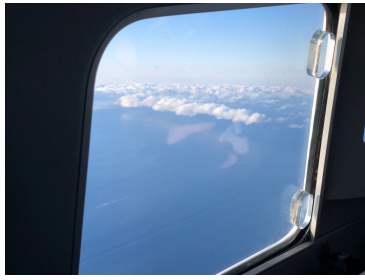
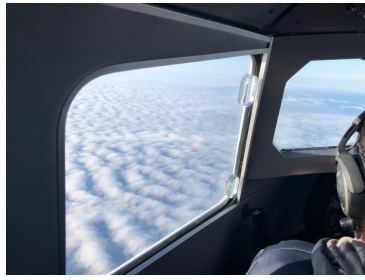
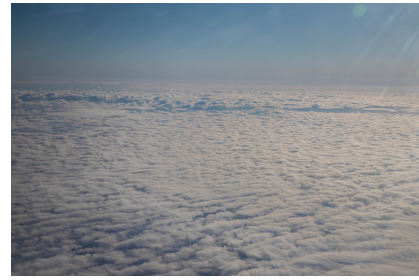
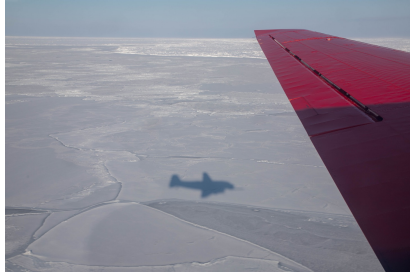
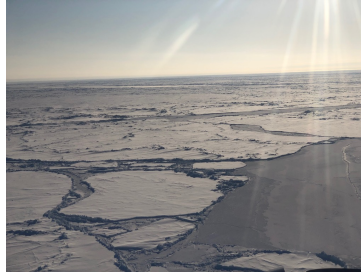
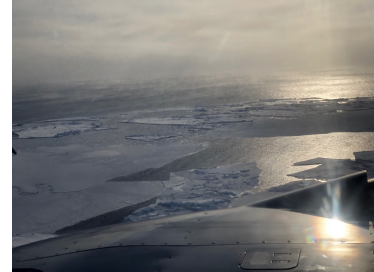
Fig. 7: Pictures from the cloud situation during different times of the flight.

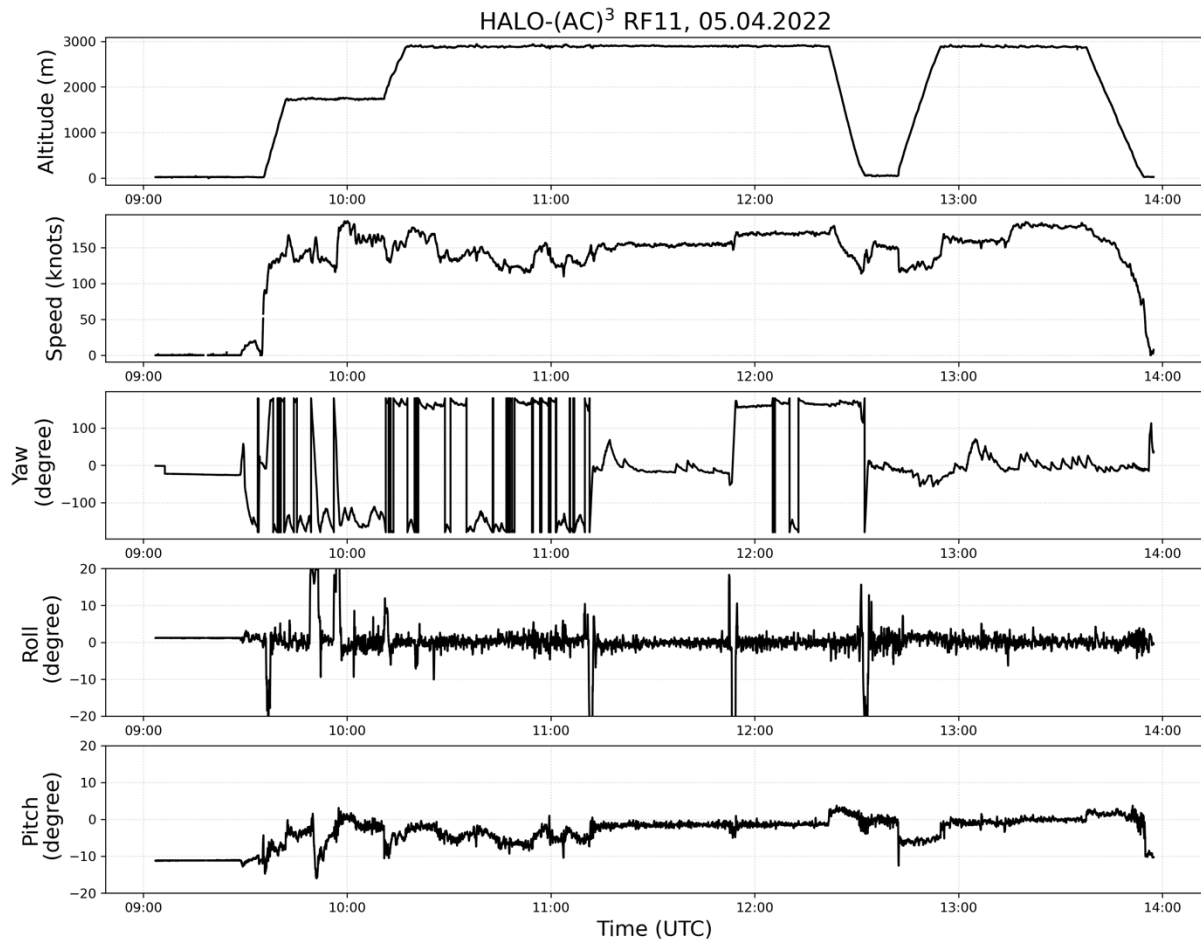
Fig. 9: Altitude, speed and attitude measurements.

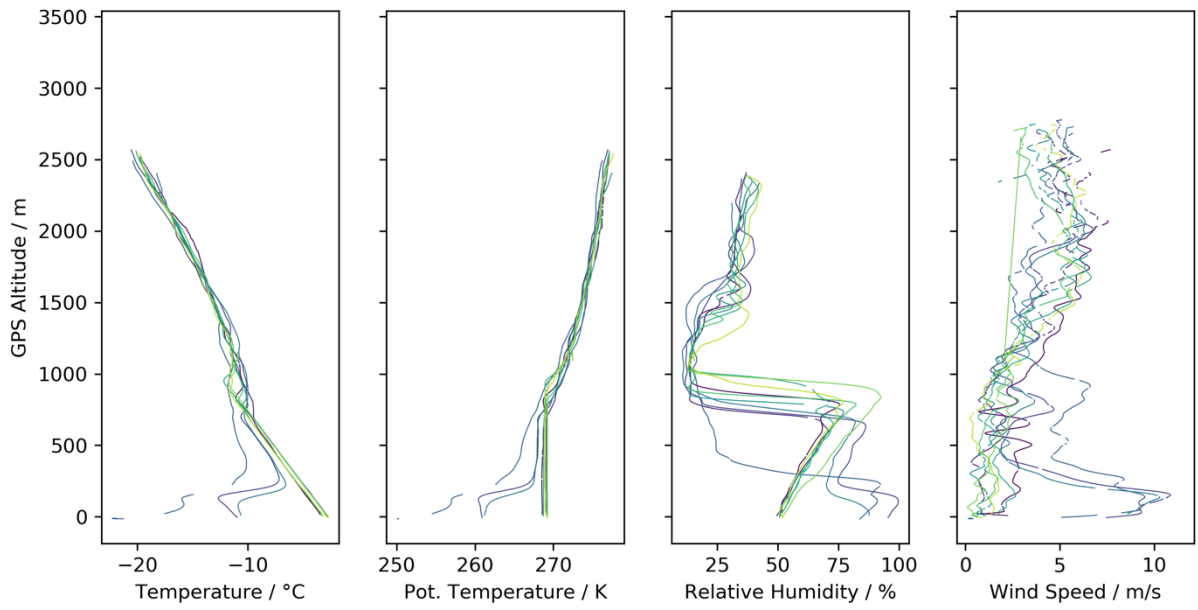
Fig. 10: Profiles of all launched drosondes.

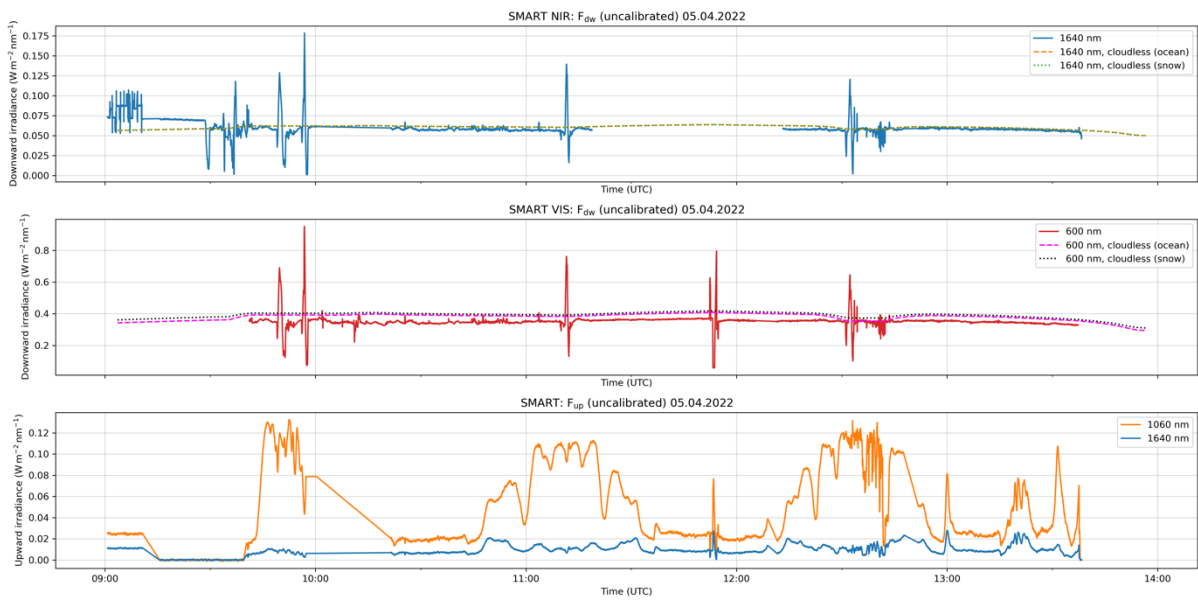
Fig. 11: SMART measurements along the flight.

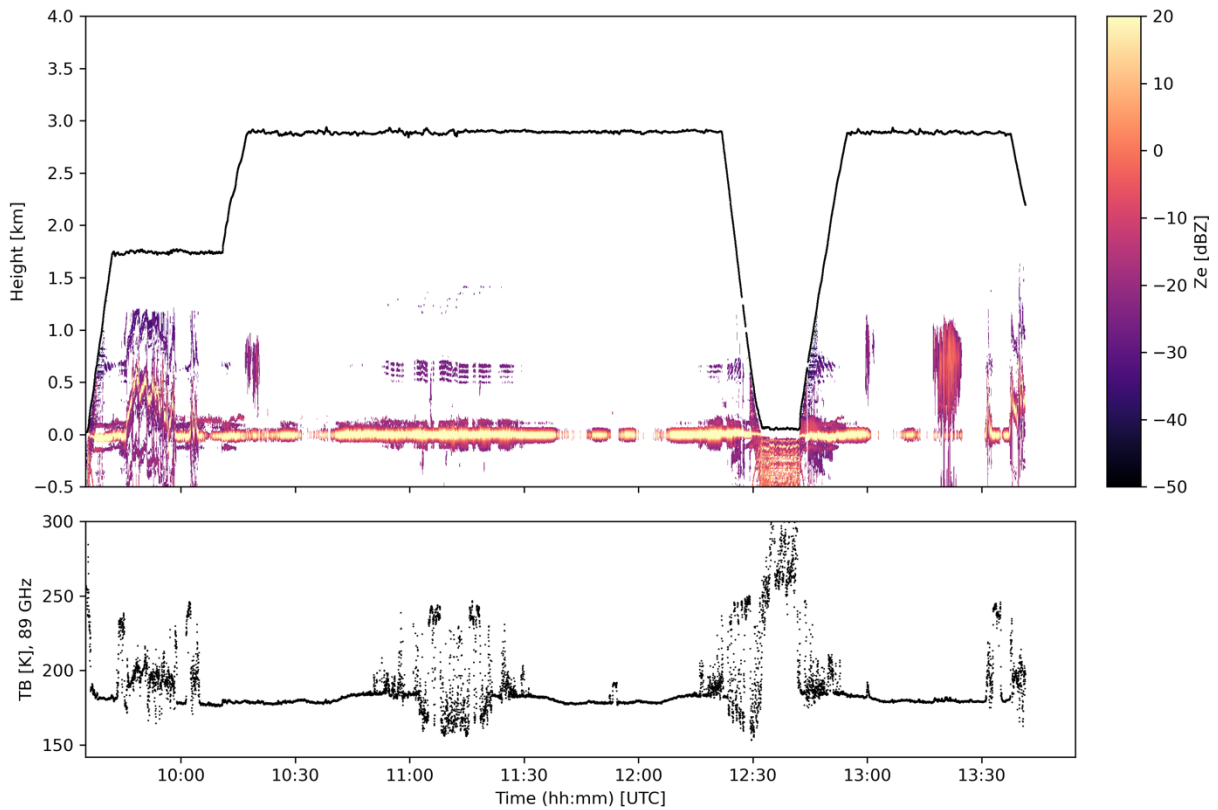
MIRAC-A, 2022-04-05, 09:35-13:54 UTC

Fig. 13: MIRAC radar measurements.

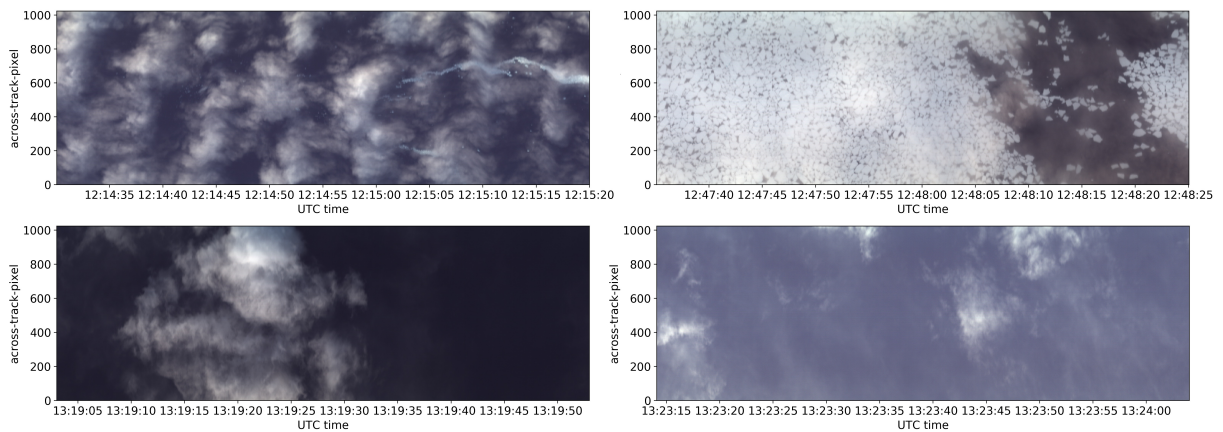
Fig. 17: RGB pictures taken by the spectral imager AISA Eagle at different times of the flight. The aspect ratio is not corrected yet.
