HALO-(AC)³ – 2022/03/26 – Polar6 research flight RF04

Objectives:

During RF04 with Polar 6 we focused on low level cloud and aerosol in-situ measurements during a cold air outbreak in the Fram Strait over the marginal sea ice zone and over the open ocean.

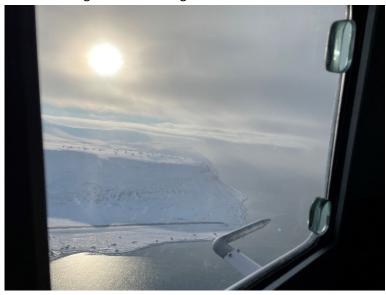
- 12:32 crossing some clouds right after T.O.

- **12:33** exiting cloud cloud top @3300ft
- 12:40 UTC: Roller doors won't open (no BCPD)
- **12:51** UTC: Instrument update: CVI, PIP PWR, PN PWR, deicing 2D-S -> power loss; dynamic pressure not working, ALABAMA works!
- 12:55 UTC: power is back in the PMS rack (115V)
- 13:06 UTC: we start our descent to 200ft
- **13:13** UTC: some aerosol layer reported at 2km altitude
- **13:17** UTC: broken clouds below us

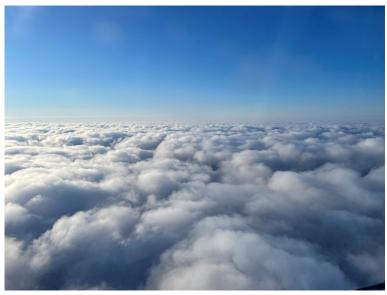
- 13:18 UTC: reaching cloud top 1700ft, further north cloud top is estimated at 1200ft (from cockpit)
- **13:21** UTC: cloud bottom @400ft; foggy but visibility is ok to continue; no icing; surface: MIZ, small size ice floes with mostly frozen water in between

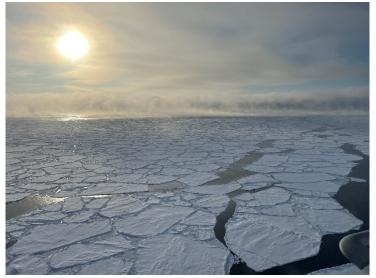
- 13:23 UTC: Reaching WP1, now heading to WP2. Start with INP leg; foggy

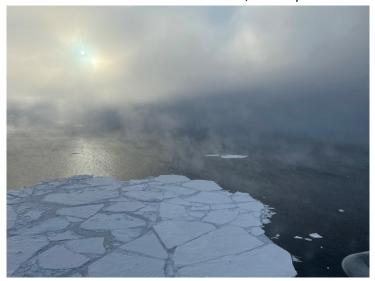
- **13:24** UTC: we see the sun, clouds get broken
- **13:25** UTC: ice concentration decreases, visibility decreases

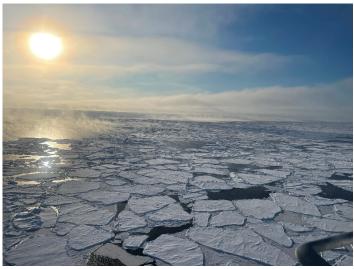
- 13:28 UTC: visibility gets worse, more open sea, hardly any ice
- 13:29 UTC: visibility gets very good again, dense ice at the bottom

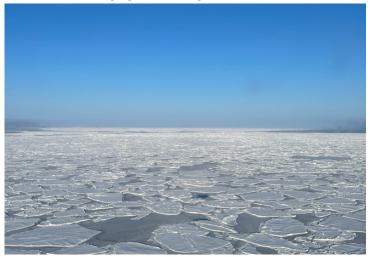
- 13:37 UTC: finished procedure turn now heading back @200ft to WP1
- 13:43 UTC: sea fog again and large areas of free ice

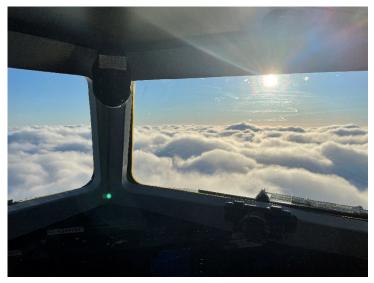
- 14:36 UTC: start sawtooth pattern; 1300ft
- 14:38 UTC: reaching 200ft altitude; broken clouds ascend again, rise through a cloud hole
- **14:43** UTC: cancelation of the sawtooth pattern some scientists do not feel well; instead we fly an aerosol leg just above cloud top to W4
- 14:45 UTC: cloud top rises, as we want to stay above cloud we ascent to 2800ft
- **14:48** UTC: cloud top rises ascend to 3500ft
- **14:54** UTC: cloud top rises ascend to 3800ft
- **14:56** UTC: cloud top rises ascend to 4100ft

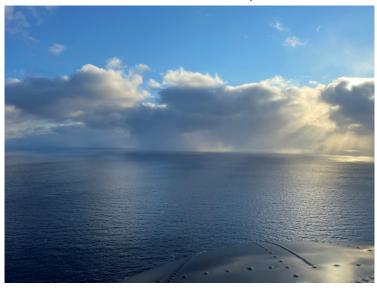
- **15:05** UTC: cloud top rises ascend to 4600ft
- **15:06** UTC: until this point clouds were non broken, now we start seeing the ocean from time to time
- 15:09 UTC: start to descend to WP4; inversion at 1200m
- **15:10** UTC: now in cloud
- **15:13** UTC: trace icing
- **15:13** UTC: descending through a broken cloud
- 15:15 UTC: hard to determine cloud base; broken clouds with heavy precipitation

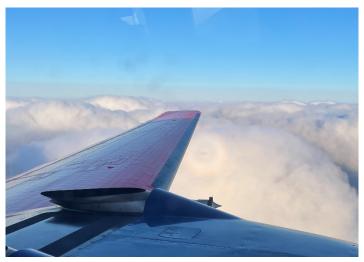
- 15:23 UTC: on the leg to W4; leg for INP measurements to W5 and back to W4 @200ft
- **15: XX** UTC: second leg @2300ft
- 15:49 UTC: turn at WP6; cloud base is estimated at 2200ft
- 15:50 UTC: climb and turn to next leg @3100ft
- 15:53 UTC: broken cloud
- **16:00** UTC: now leg @3900ft leg, right in cloud top
- **16:05** UTC: done with leg @3900ft, now turn and climb to 5200ft leg between W6 and W4 (above clouds leg for aerosols)

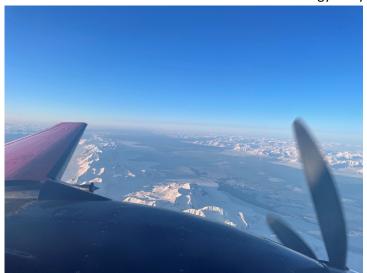
- **16:13** UTC: done with the second staircase, now going to 6000ft for trace gas calibration for 3min
- **16:19** UTC: done with the leg at 6000ft now climb to 12000ft
- **16:20** UTC: Another inversion layer observed @1650m
- **16:27** UTC: leg @12000ft for trace gas measurements
- **16:37** UTC: leg @14000ft for trace gas measurements
- **16:38** UTC: done with science we head back to Longyearbyen
